**HISTORIC STRUCTURES REPORT**  
for  
**GRAND HAVEN SOUTH PIER**  
**ENTRANCE AND INNER LIGHTS**  
Grand Haven (Ottawa County), Michigan

**Grand Haven Lighthouse Conservancy**  
and  
**City of Grand Haven**  
519 Washington Avenue  
Grand Haven, Michigan 49417

**Sanders & Czapski Associates, PLLC**  
109 S. Front Street, Suite #210  
Marquette, Michigan 49855

**FINAL REPORT**  
**September 8, 2015**

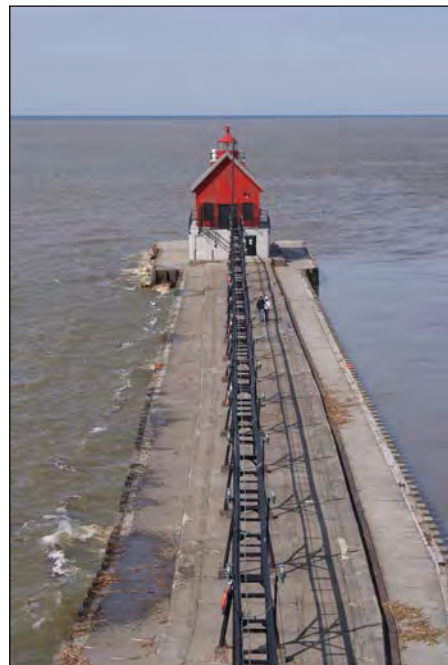
**Photo III-A-4**

The 37 foot wide pier surface, or superstructure, was modified and repaired many times from 1916 through the 1960s. The last segment of the pier that surrounds the Entrance Light was constructed with a width of 51 feet – 6 inches. The eastern terminus of the pier now joins a public walkway along the Grand River that connects with public parking areas within the Grand Haven State Park. Photos III-A-5, III-A-6, III-A-7, and III-A-8 show various views of the approach to the pier. A continuous metal railing serves as a barrier at the river along this walkway and a small concrete ramp provides access onto the pier. The public parking areas, as seen in Photos III-A-9 and III-A-10, provide convenient parking a reasonable distance from the pier. A motor vehicle permit is required for entry to these parking areas, however, pedestrians are free to enter the site at various points. While there are no restroom facilities on the pier there are a number of public facilities near the parking lot area conveniently located for visitors. Permanent facilities are shown in Photos III-A-11 and III-A-12. Portable toilets, Photo III-A-13, are occasionally placed for seasonal use, but are not normally available.

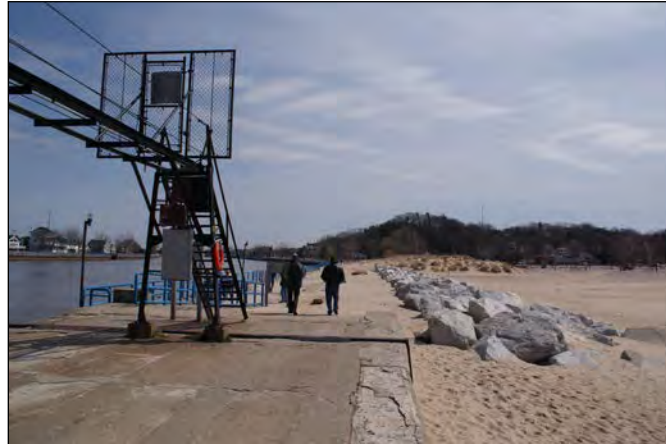
**Photo III-A-17**

Public access to the pier is unrestricted and it is an extremely popular destination for fishermen, tourists, bicyclists, park visitors and sightseers. An unprotected pier extending into the lake is often a dangerous place and signage at the terminus of the pier states that the pier “is not designed for public access” and that dangers and hazards are present as seen in Photos III-A-14, III-A-15 and III-A-16. The metal railing along the public walkway along the river’s edge abruptly ends at the small ramp at the beginning of the pier leaving the pier surface unprotected from the water’s edge. Refer to Photo III-A-17.

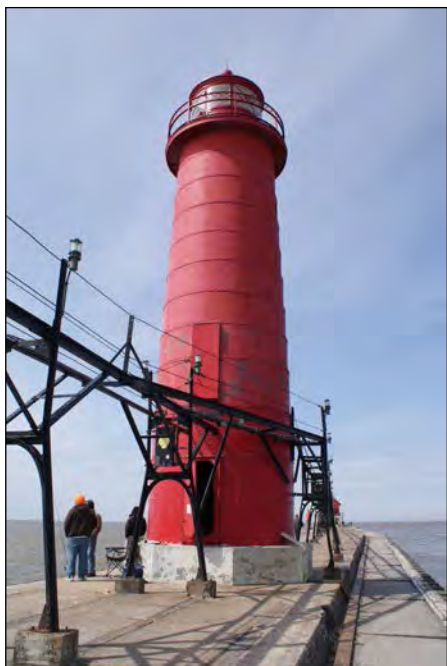
**Photo III-A-23**

The Inner Light, placed approximately halfway along the length of the pier, is situated upon an eight sided concrete base, Photo III-A-23, that is 2'-8" above the main pier deck surface. Access around the structure's base is maintained at the main pier deck surface as seen in Photo III-A-24. At the Entrance Light, located at the far western end, there is a 1'-1" step up from the main pier deck surface to the walkway at the entry to the structure, as seen in Photo III-A-25. Further discussion of these areas are found in the respective sections describing the existing conditions of the Entrance and Inner Lights.

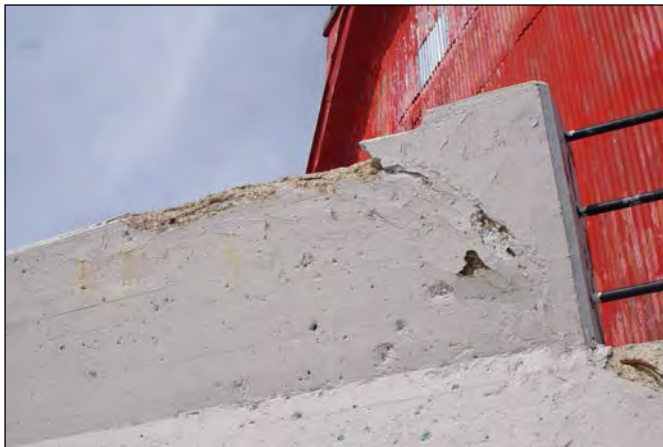
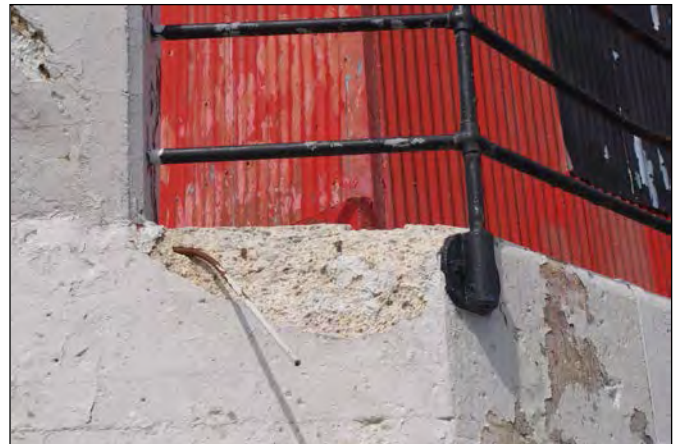
Exterior concrete surfaces are, in general, in fair condition although there are many areas where severe spalling has occurred which has exposed the reinforcing steel. Refer to Photos III-B-5 and III-B-6. Additional information is found in the Exterior Conditions and Analysis section.

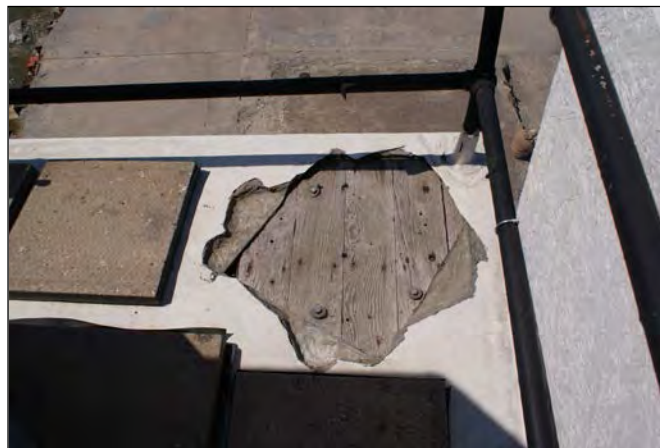
**Photo III-B-15**

Finish material in the Lantern Room was not removed as part of this investigation and the wood frame structure could not be seen. The lantern deck has been covered with a PVC single-ply membrane that has a very large section missing at the northwest corner, as seen in Photo III-B-15, exposing the wood deck and creating a major point of entry for water into the structure. The wood decking appeared sound, however, this situation warrants immediate repair.

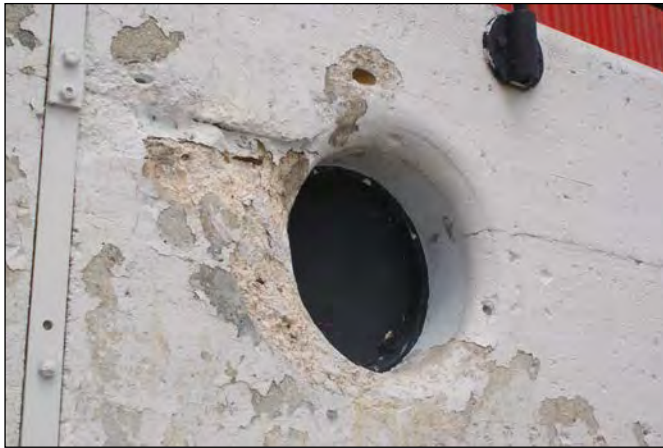
**Photo III-B-20**

The vertical poured concrete walls of the Entrance Light are in fair condition with some areas of spalling as seen in Photos III-B-20, III-B-21, III-B-22 and III-B-23. A cast iron clean-out, Photo III-B-24, is cast into the south wall. This clean-out served the sanitary waste line in the main level of the building.

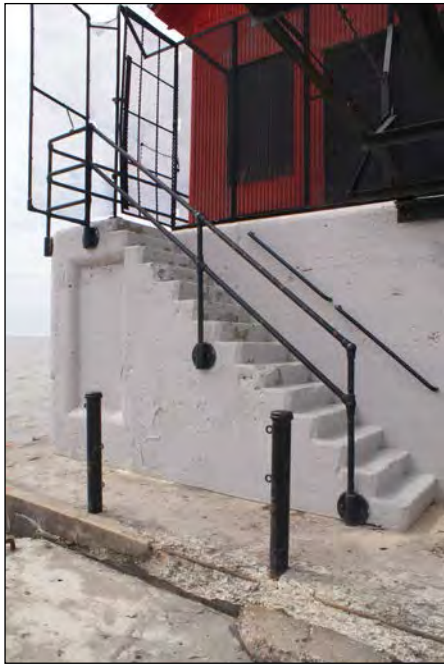
**Photo III-B-25**

A set of cast concrete steps is located at the southeast corner of the building and provides access to the upper level walkway as seen in Photo III-B-25. There is extensive deterioration of the concrete steps including cracking and spalling. Refer to Photos III-B-26 and III-B-27. A metal pipe handrail, which is in good condition, is anchored to the concrete wall and a 1 ¾" metal pipe handrail/guardrail is bracketed to the face of the exposed stairway wall. This handrail/guardrail is in poor condition. The base of the lowest support post, as seen in Photo III-B-28 has completely rusted and broken loose from the support bracket. Severe rusting has also occurred at other post bases and brackets.

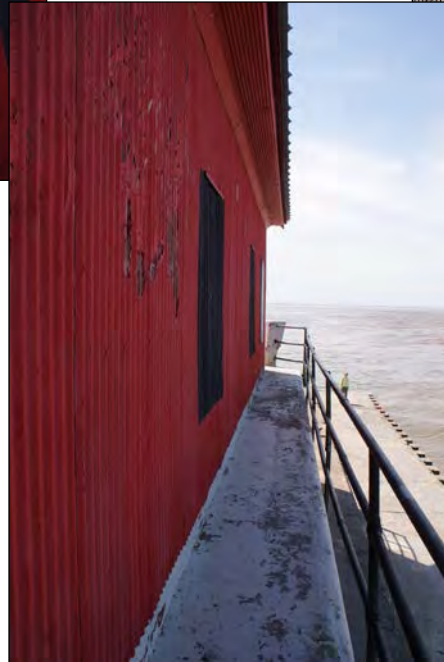
**Photo III-B-31**

The upper level walkway which is also the roof of the main level, is 2' – 2" wide on the north side, Photo III-B-31; and south side, Photo III-B-32 and 4' – 0" wide on the east side, Photo III-B-33. Spalled concrete edges present a safety hazard as seen in Photo III-B-34. The narrow walkway transitions to a larger deck at the west end "bow". Refer to Photos III-B-35 and III-B-36. Poured concrete walls form the guardrail along this area. The paint on these walkway surfaces, which is also the roof surface for the lower level, is in poor condition and there is some minor cracking. A metal coal room hatch, as seen in Photos III-B-37 and from the interior in Photo III-B-38, is located on this deck. The metal hatch cover and frame are rusted and the paint is in poor condition.

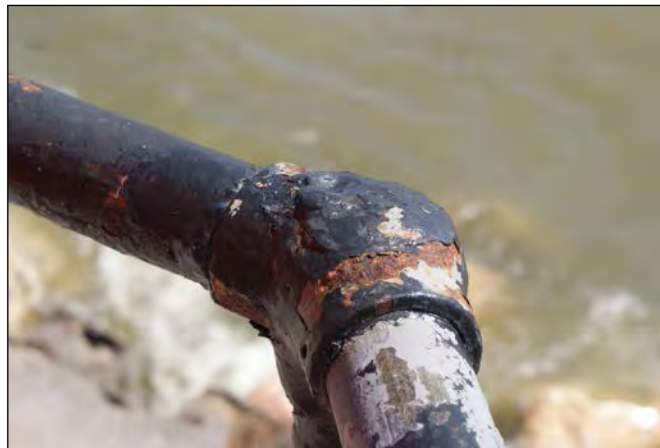
**Photo III-B-43**

A 3' – 6" metal pipe guardrail with three horizontal rails extends around this upper level walkway. The guardrail is constructed of 1 ¾" diameter metal pipe as seen in Photos III-B-39 and III-B-40. Similar to the railing at the stair, the guardrail posts are bracketed to the face of the concrete wall surface. Refer to Photos III-B-41 and III-B-42. Three of the guardrail pipe posts have been replaced with 2 x 2 steel angle. Many of the metal pipe guardrail components are in poor condition with members bent and rusted. The paint finish, Photo III-B-43, is in poor condition.

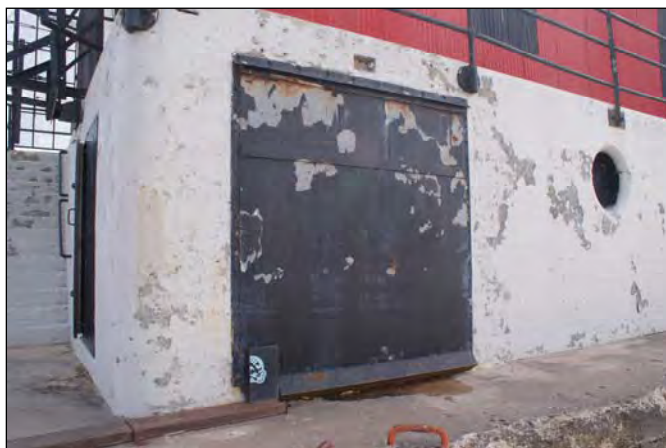
**Photo III-B-69**

Adjacent to the watertight door is a large door measuring 6' – 8" wide x 6' – 11 ½" high that served as the door into the boat room, as seen in Photo III-B-69. Original drawings indicate doors with half glass lights, however, these doors have been removed and replaced with steel plates. Additional bracing has been installed and welded to the steel plate as seen in Photo III-B-70. The door and frame are in poor condition with extensive rust and deterioration. A large floor drain, Photo III-B-71, is found inside this door and is in similar poor condition. The paint finish on all door, frame and grating components is very poor.

A hand operated derrick, as detailed in historic drawing # RHL1018434, was located above this boat room door to facilitate the handling of boats and materials. Although this derrick is no longer extant, bolt locations for the original mounting brackets above the doors are still visible as seen in Photo III-B-69.

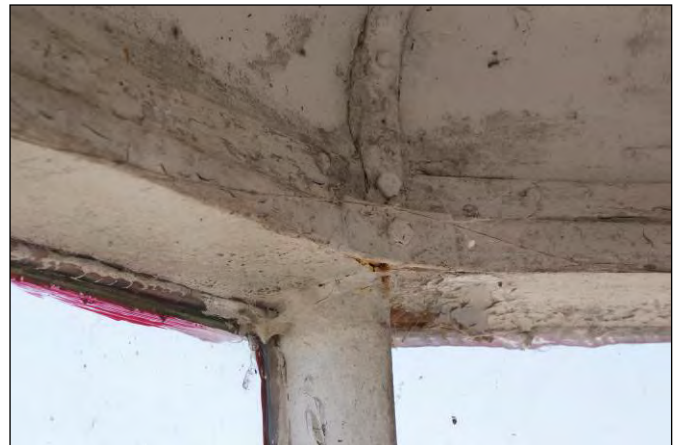
**Photo III-B-130**

Of the eight glazed openings in the Lantern three panels are glazed with Lexan material and two of the remaining five glass panels are broken. The glazed openings measure 2'-4 ½" wide x 3'-0 ½" high. The exposed metal sill and vertical mullions of the lantern are in good condition, however, the paint is in poor condition. There is considerable moss growth along the metal sill, as seen in Photo III-B-127. The lantern ceiling is exposed light gage metal with a paint finish. All metalwork is in sound condition, however, the paint finish on all surfaces is in poor condition. Refer to Photos III-B-128, III-B-129 and III-B-130.

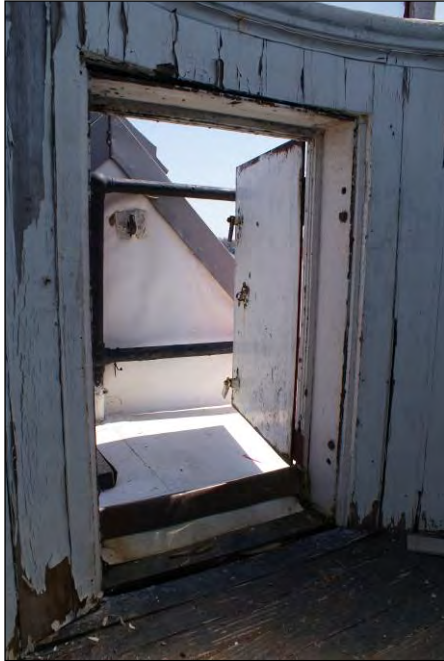
**Photo III-B-131**

The exterior of the lantern and the lantern deck is accessed through a 1'-8" wide x 2'-5" high access door on the east side of the lantern. Refer to Photo III-B-131. The door is a ¼" thick metal door as seen in Photo III-B-132. The door is in good condition, however, the metal flashing and roof membrane flashing at the door sill is in poor condition as seen in Photos III-B-133 and III-B-134. The wood floor and wood trim at the base is also in poor condition around the door opening.

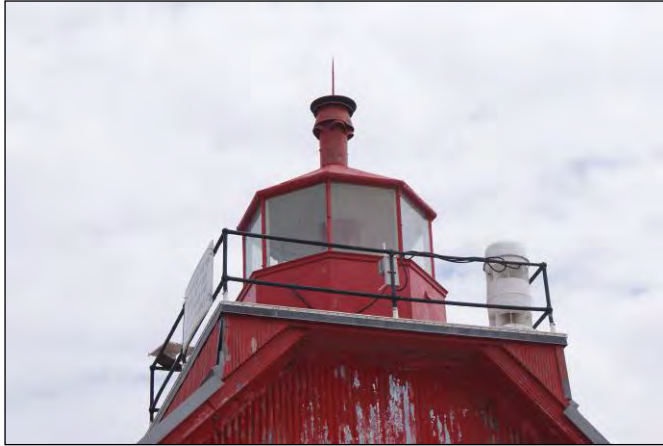
**Photo III-B-135**

The exterior of the lantern is shown in Photos III-B-135 and III-B-136. Exterior walls of the lantern are flush metal with a paint finish. Vents are simple capped openings, as seen in Photo III-B-137. Minor areas of damage including rust are found in various locations, as seen in Photos III-B-138, III-B-139 and III-B-140. The lantern roof is flat metal panels terminating at a simple fascia without gutters. All exterior metal on the lantern is in good condition. The paint finish is in average condition. At the peak of the lantern is a ventilator that was apparently installed as part of the 1922 renovation. It is identified as a “new ‘Kernchen’ ventilator” on these drawings and is shown in Photo III-B-141.

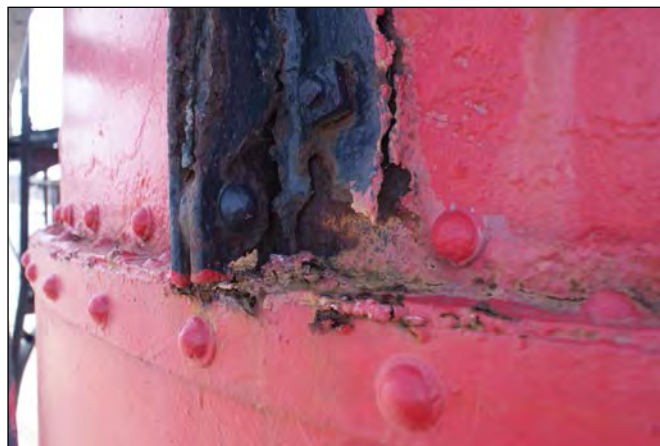
**Photo III-C-2**

The cylindrical tower is constructed of cylindrical metal rings and angles. The bottom section of the tower base is 12'-6" outside diameter and steps down in 3" increments to 10'-0" outside diameter at the top section below the lantern deck. These metal sections form the walls and the structure of the tower. Original 1902 drawings indicate plate thicknesses of 3/8" at the lower three sections of the tower, and incrementally stepping down to 5/16", 1/4" and 3/16" in plate thickness. Riveted metal angle seats form the bearing points between the cylindrical sections. These horizontal ledges tend to trap water causing rust and scale to form, as seen in Photo III-C-2.

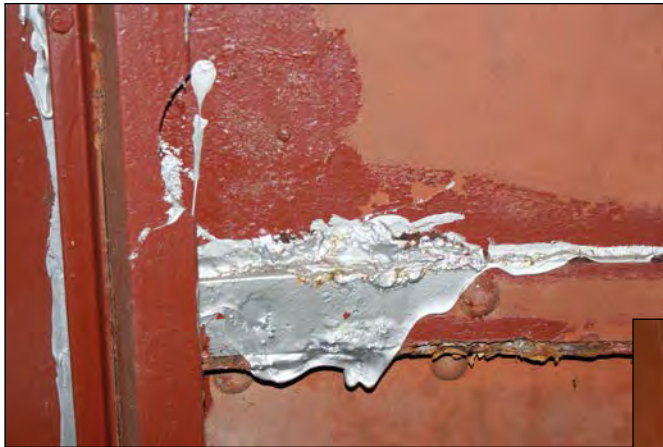
**Photo III-C-3**

Interior views of these horizontal joints are shown in Photos III-C-3 and III-C-4 which show rust sealant material, and coatings of rust inhibitive primer. Internally there are a number of struts, bracing and other metal framework that reinforce the structure and provide framing for the floors. Photos III-C-5 and III-C-6 show some of the internal framework, which is in relatively good condition.

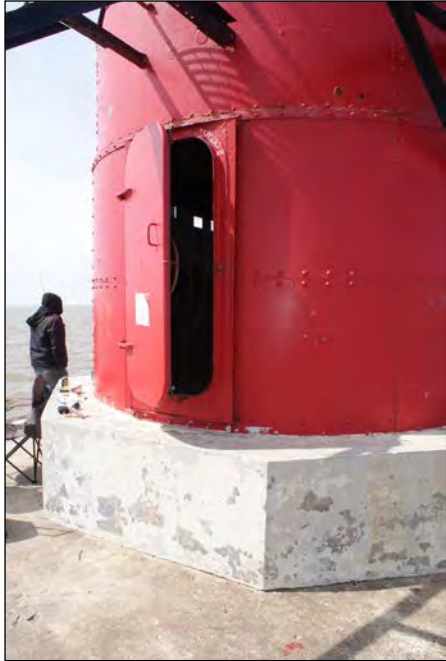
Photo III-C-27

The Inner Light tower is entered through a 2'-2" x 5'-6" gasketed, water-tight steel door, as seen in Photos III-C-27, III-C-28 and III-C-29. This style of door also has a continuation of the frame at the bottom of the opening, requiring extra caution when stepping through. This condition is seen in Photo III-C- 30. The door hardware consists of a pull handle and padlock hasp on the exterior and a multi-point lock mechanism on the interior. All door components are in good condition and operating order. Paint finish is in poor condition. The original 1922 drawings indicate a solid steel plate door. The water-tight door was installed in the 1990s.

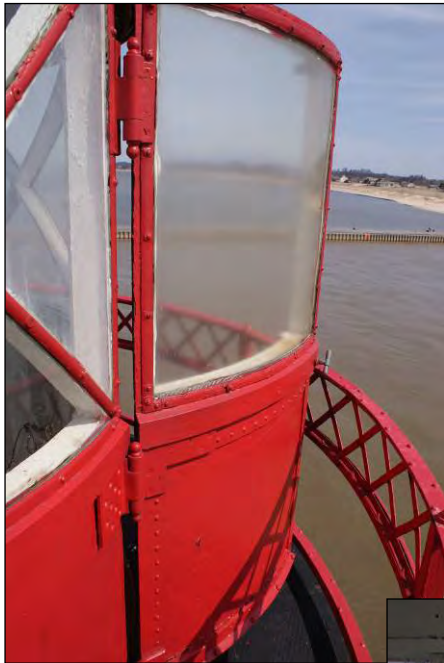
**Photo III-C-34**

The lantern door is a large metal and glass door 2'-3 ½" wide by 5'-10" high that is curved to match the curvature of the lantern. Refer to Photos III-C-34, III-C-35 and III-C-36. The original curved glass has been replaced with Lexan. There is a major crack in the metal door at the lower northern corner of the glazed opening directly above the latch. The crack is completely through the metal and affects the integrity of the door. Another area of concern is a loose middle hinge, as seen in Photos III-C-37. This hinge is no longer connected to the body of the lantern, with the door only supported on the lower and upper hinge, Photo III-C-38. The head and sill of the door are shown in Photos III-C-39 and III-C-40. Door frame metalwork is in good condition, however, all paint finishes are in poor condition. Door hardware consists of a small turn handle on the exterior, Photo III-C-41, and partial components of a vertical rod latch mechanism, Photo III-C-42. Remnants of the vertical rod latch device are laying in the lantern, as seen in Photo III-C-43.

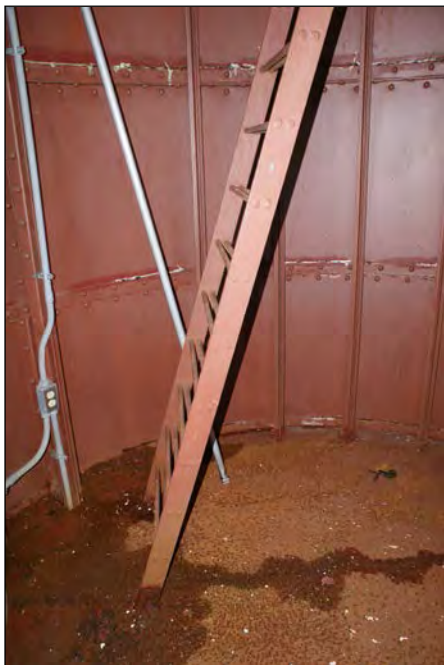
**Photo III-C-67**

A fixed steel ladder with double rungs provides access to the lantern. Refer to Photo III-C-67. A 1'-11" x 2'-5" floor opening in the lantern floor is seen in Photos III-C-68 and III-C-69. Two damaged hinges, Photo III-C-70, are found along the edge of the opening and the steel plate hatch cover is removed and laid against the lantern wall as seen in Photo III-C-71. The ceiling of the third level, or the underside of the lantern deck floor, is cement plaster which is in poor condition. Photo III-C-72 shows the loose and missing plaster. The paint finish is in poor condition.
