**HISTORIC STRUCTURES REPORT**  
for  
**GRAND HAVEN SOUTH PIER**  
**ENTRANCE AND INNER LIGHTS**  
Grand Haven (Ottawa County), Michigan

**Grand Haven Lighthouse Conservancy**  
and  
**City of Grand Haven**  
519 Washington Avenue  
Grand Haven, Michigan 49417

**Sanders & Czapski Associates, PLLC**  
109 S. Front Street, Suite #210  
Marquette, Michigan 49855

**FINAL REPORT**  
**September 8, 2015**

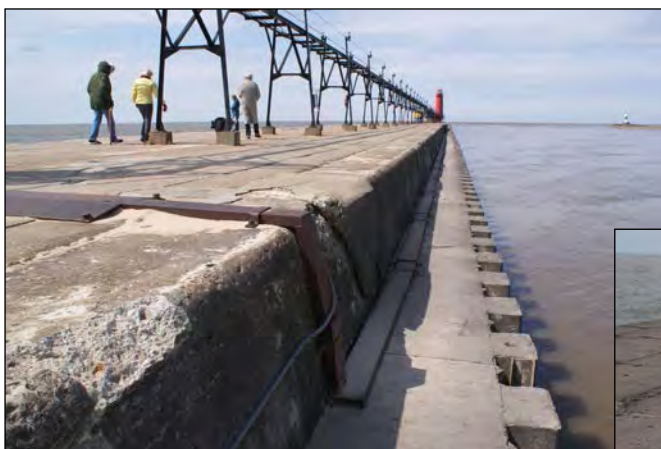
**Photo III-A-18**

The traffic surface of the pier is concrete which is in fair condition, however, there are many areas of deterioration and many potential tripping hazards as seen in Photos III-A-18, III-A-19 and III-A-20. The elevation of the walking surfaces changes a number of times along its length and width with steps and sloped ramp surfaces providing the transition between levels. Refer to Photos III-A-21 and III-A-22. Although there are areas of concern, the pier in general, provides a barrier free accessible, albeit somewhat dangerous, walkway from the State Park parking lot to the Entrance and Inner Light structures.

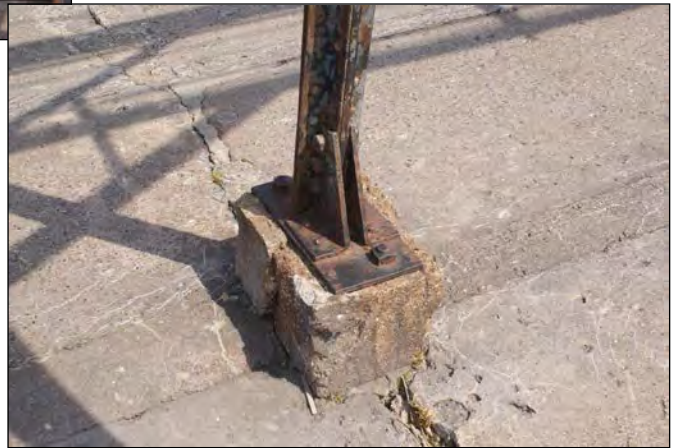
Photo III-A-33

The metal stanchions consist of angles that bear upon small raised concrete piers as seen in Photo III-A-33. There is localized damage at the lower portions of some of the stanchions including bent and damaged members and some rusting, as seen in Photos III-A-34 and III-A-35, along with some damaged and spalling concrete at the raised support piers. These areas appear to be minor and the overall integrity of the catwalk appears sound, however, further evaluation and monitoring is recommended. The walking deck surface of the catwalk was removed in 1988 for safety reasons and to raise funds by salvaging the wood planks for donors. Presently the catwalk serves only as a support structure for the lighting system, Photo III-A-36, electrical panels, Photo III-A-37 and some public safety equipment, Photo III-A-38.

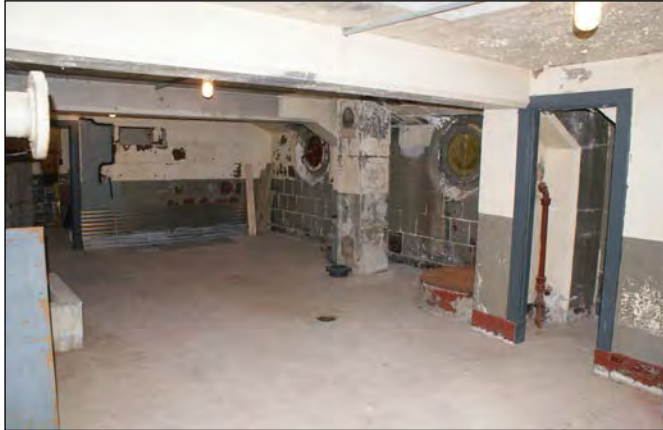
**Photo III-B-3**

seen in Photo III-B-3 showing the concrete beams, columns and underside of the structural slab that forms the finished ceiling. One concrete beam near the entrance door is damaged and has a large vertical crack. Two supplementary wood columns, 3 ½" x 5 ½" in size, have been installed to provide support as seen in Photo III-B-4. The floor / ceiling slab, beams and columns otherwise are all in good condition with some minor areas of spalling on the interior.

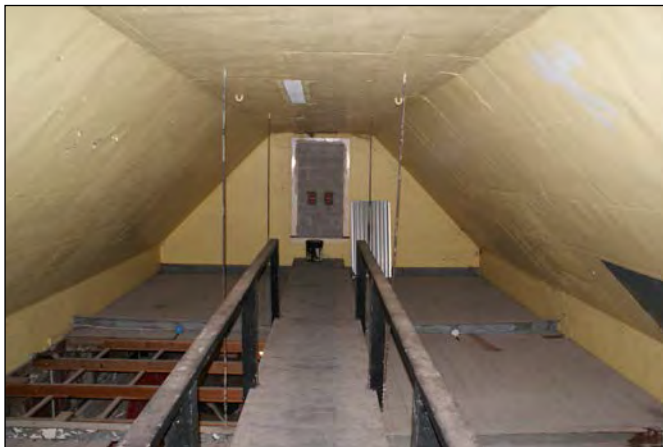
**Photo III-B-13**

From the upper floor level a steep wood stair provides access to a walkway that leads to the Service Room below the Lantern Room. This walkway runs the length of the building and once provided access from the elevated catwalk prior to 1922 into the building through a door at the gable end, Photo III-B-13, now closed off. Four  $\frac{1}{2}$ " diameter steel rods support two 5" deep c-channels that span between outside walls and provide support for the walkway. Floor/ceiling rafters in this area are  $1\frac{3}{4}$ " x  $5\frac{7}{8}$ " wood rafters spaced 16" on center. Part of the floor is decked with random width  $\frac{3}{4}$ " tongue and groove wood plank, part with plywood and part of the floor is open. All structural members appeared in reasonably good condition.

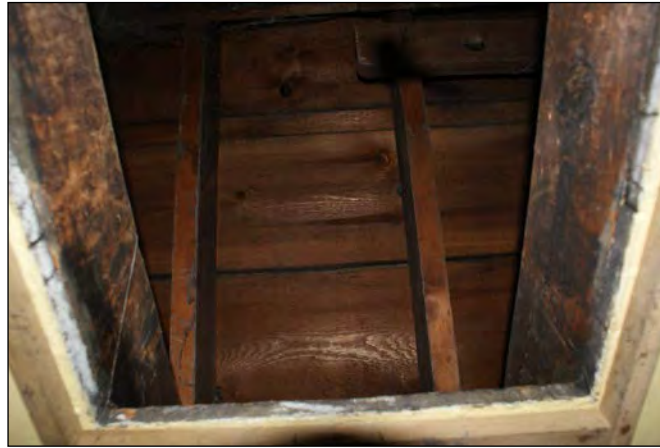
**Photo III-B-14**

The building roof is wood framed with 1¾" x 5 7/8" wood rafters spaced 16" o.c. Roof sheathing is 1" thick random width planking. A partial view of the roof structure is shown in Photo III-B-14 looking up through the attic access hatch. Where observed, the roof framing appeared to be in sound condition.

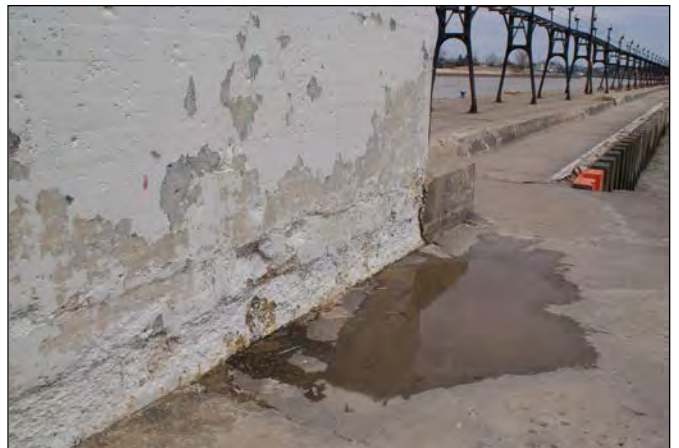
**Photo III-B-21**

The vertical poured concrete walls of the Entrance Light are in fair condition with some areas of spalling as seen in Photos III-B-20, III-B-21, III-B-22 and III-B-23. A cast iron clean-out, Photo III-B-24, is cast into the south wall. This clean-out served the sanitary waste line in the main level of the building.

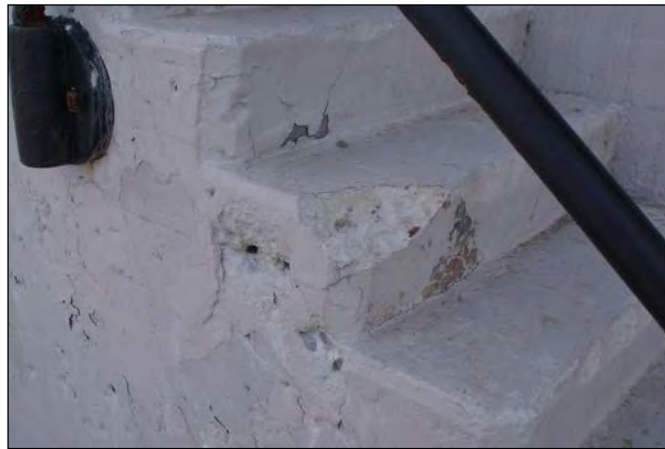
**Photo III-B-26**

A set of cast concrete steps is located at the southeast corner of the building and provides access to the upper level walkway as seen in Photo III-B-25. There is extensive deterioration of the concrete steps including cracking and spalling. Refer to Photos III-B-26 and III-B-27. A metal pipe handrail, which is in good condition, is anchored to the concrete wall and a 1 ¾" metal pipe handrail/guardrail is bracketed to the face of the exposed stairway wall. This handrail/guardrail is in poor condition. The base of the lowest support post, as seen in Photo III-B-28 has completely rusted and broken loose from the support bracket. Severe rusting has also occurred at other post bases and brackets.

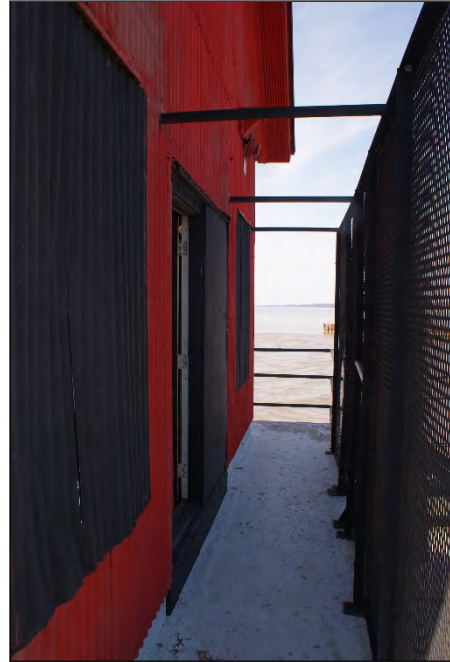
Photo III-B-33

The upper level walkway which is also the roof of the main level, is 2' – 2" wide on the north side, Photo III-B-31; and south side, Photo III-B-32 and 4' – 0" wide on the east side, Photo III-B-33. Spalled concrete edges present a safety hazard as seen in Photo III-B-34. The narrow walkway transitions to a larger deck at the west end "bow". Refer to Photos III-B-35 and III-B-36. Poured concrete walls form the guardrail along this area. The paint on these walkway surfaces, which is also the roof surface for the lower level, is in poor condition and there is some minor cracking. A metal coal room hatch, as seen in Photos III-B-37 and from the interior in Photo III-B-38, is located on this deck. The metal hatch cover and frame are rusted and the paint is in poor condition.

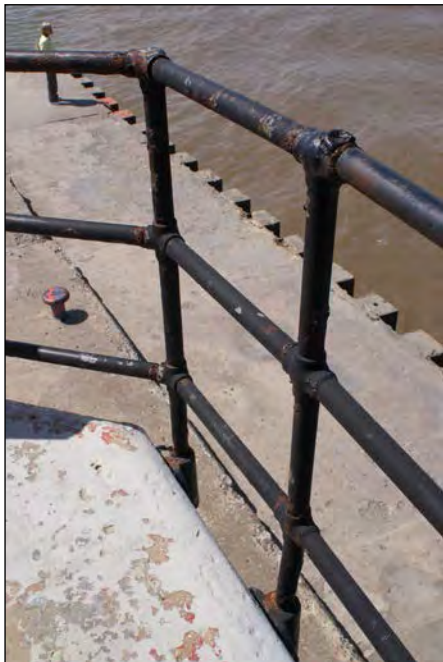
**Photo III-B-39**

A 3' – 6" metal pipe guardrail with three horizontal rails extends around this upper level walkway. The guardrail is constructed of 1 ¾" diameter metal pipe as seen in Photos III-B-39 and III-B-40. Similar to the railing at the stair, the guardrail posts are bracketed to the face of the concrete wall surface. Refer to Photos III-B-41 and III-B-42. Three of the guardrail pipe posts have been replaced with 2 x 2 steel angle. Many of the metal pipe guardrail components are in poor condition with members bent and rusted. The paint finish, Photo III-B-43, is in poor condition.

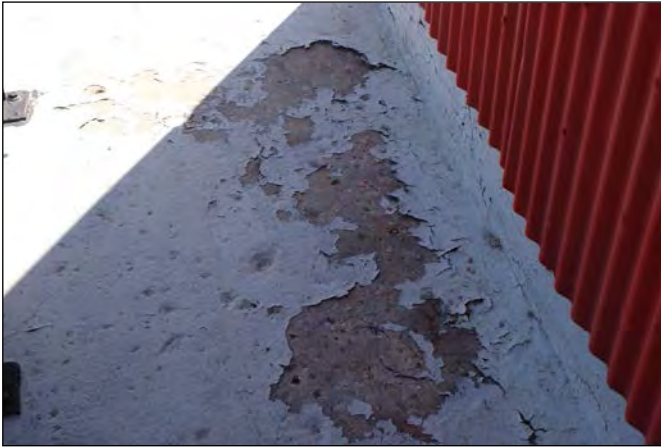
Photo III-B-44

The wood frame structure of the original Fog Signal Building is placed on an 8" high poured concrete curbs that extend around the perimeter. On three sides the corrugated metal siding overlaps this curb, Photo III-B-44; however, it transitions to a different condition on the west side as seen in Photo III-B-45. On the west side repairs or modifications have been made and the concrete curb was extended and poured over the face of the corrugated metal siding. This condition is seen in Photos III-B-46, III-B-47 and III-B-48. In addition to the voids and missing concrete, there is a gap between the concrete and the corrugated metal siding, as seen in Photo III-B- 49 that allows water to flow down the siding face and penetrate the curb.

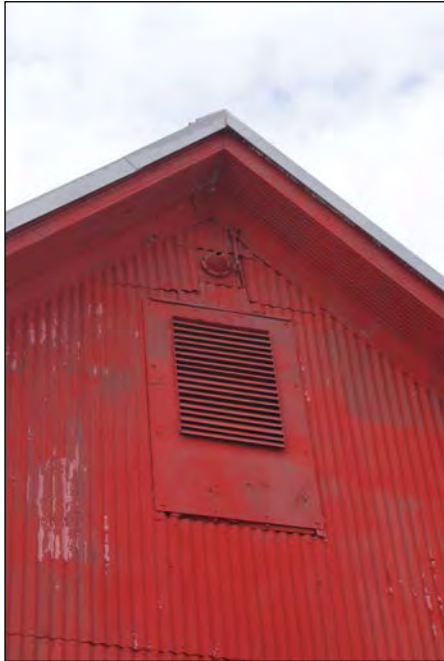
Photo III-B-53

A number of objects including a fixed ventilation louver, Photo III-B-53, an equipment support bracket and radio beacon high voltage wire terminal, Photo III-B-54, are located on the east wall of the building.

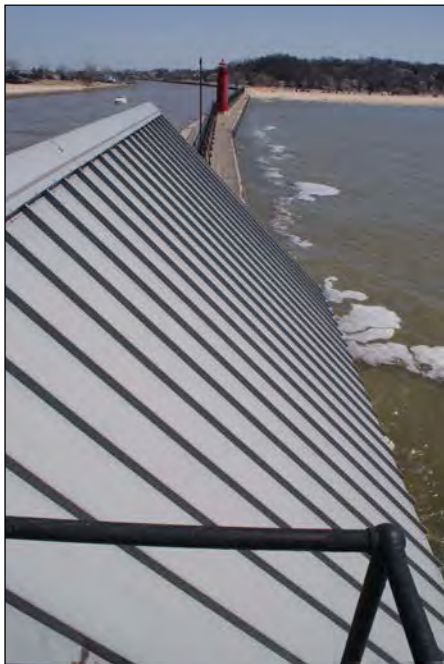
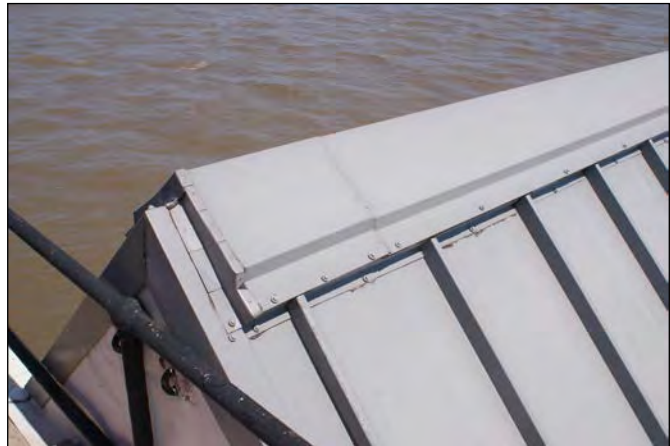
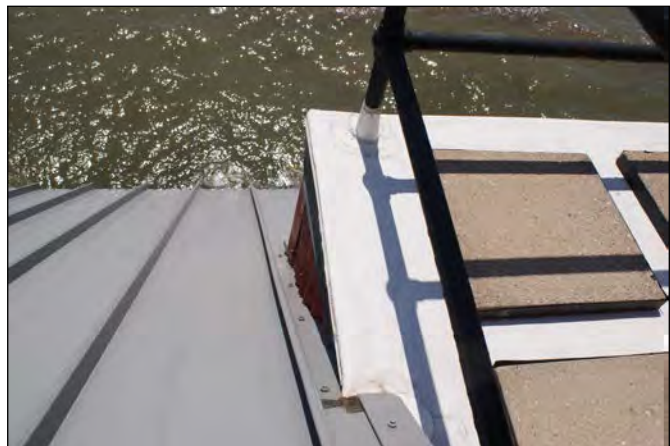
The main roof of the Entrance Light is covered with a concealed fastener standing seam metal roof that is painted a medium grey color. The roof, seen in Photos III-B-55, III-B-56, and III-B-57, has 2" high ribs spaced 16" on center. This roof was installed in 2006 and is in very good condition. Various metal flashing and trim components, matching the same roof material color, are used throughout. Although the previous roof is reported to be a rubber membrane roof, the presence of any former roofing material was not observed.

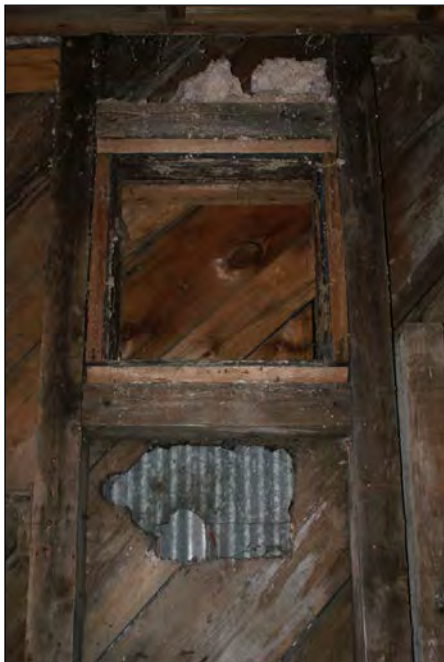
**Photo III-B-58**

All windows in the original wood frame structure have been removed and the openings either filled in with wood or concrete masonry units. A series of small framed openings measuring 1' – 7" x 1' – 7" on the north and south walls for original windows are visible from the building interior, Photo III-B-58. The 1922 drawings indicate these original windows to be removed, covered over, and new larger double hung windows to be installed. These larger window units are also no longer extant, with concrete masonry units infilling the 2' – 7" wide by 5' – 4" high openings as seen in Photo III-B-59. As previously discussed, black corrugated metal panels are placed on the exterior face to highlight the former window locations. On the main level of the Entrance Light there are seven large porthole style windows measuring 2' – 5" in diameter. The heavy glass, measuring  $\frac{3}{4}$ " in thickness, is either missing or broken in six of the seven windows, as seen in Photos III-B-60, III-B-61 and III-B-62. All windows are covered on the exterior with steel plate that is painted black. Refer to Photo III-B-63. The frames and inward opening sash of all porthole style windows are in good condition, however, some are missing. A pivoting steel sash window located below the exterior concrete stairway was also called out on the 1922 drawings. This window has also been removed and is now filled in with concrete masonry units as seen in Photos III-B-64 and III-B-65.

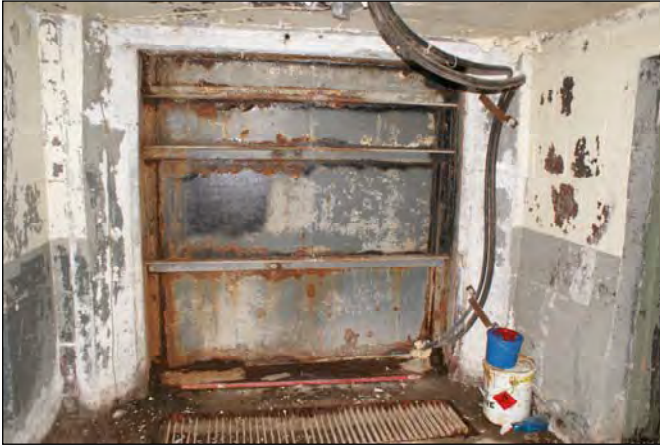
**Photo III-B-70**

Adjacent to the watertight door is a large door measuring 6' – 8" wide x 6' – 11 ½" high that served as the door into the boat room, as seen in Photo III-B-69. Original drawings indicate doors with half glass lights, however, these doors have been removed and replaced with steel plates. Additional bracing has been installed and welded to the steel plate as seen in Photo III-B-70. The door and frame are in poor condition with extensive rust and deterioration. A large floor drain, Photo III-B-71, is found inside this door and is in similar poor condition. The paint finish on all door, frame and grating components is very poor.

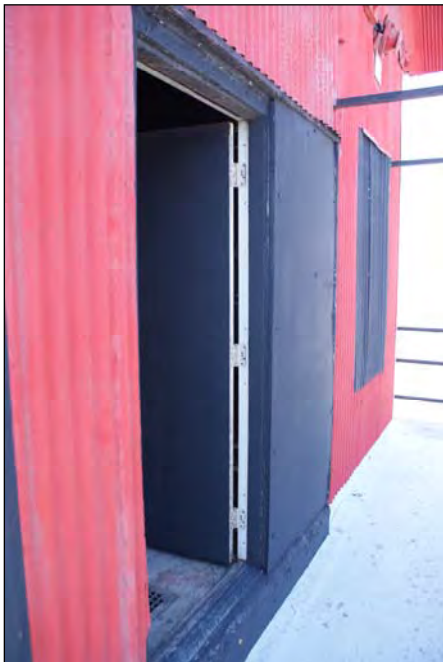
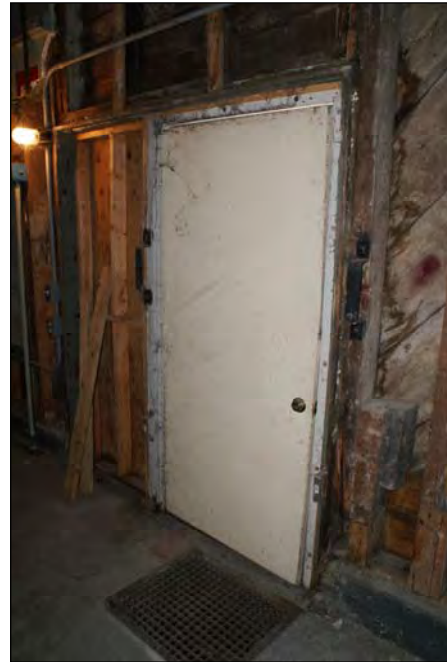
On the upper level a single 3'-0" x 6'-8" hollow metal steel door is set in a 6'-0" x 7'-0" framed door opening. This door, seen in Photos III-B-72 and III-B-73 is in poor condition and replaced a pair of doors with glass lights previously located in this opening.

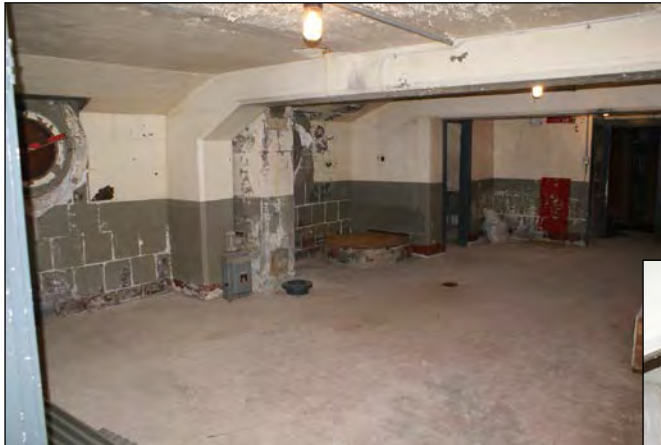
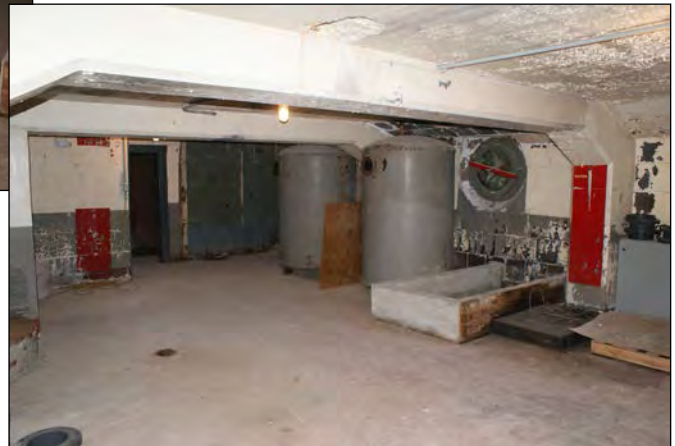
The Equipment Room is of similar construction with a poured concrete floor and ceiling and hollow glazed tile on the walls. Views of this room are shown in Photos III-B-77 and III-B-78. Photo III-B-79 shows the substantial exposed concrete column and beam that are in this space. Two large air tanks and a 1'-4" high concrete curb containment area are located on the north wall as seen in Photo III-B-80. These tanks measure 4' in diameter by 6' high. The tanks are in good condition although most of the piping is no longer present. On the south side of the room there is a brick masonry chimney, Photo III-B-81, and an 8" high curbed structure that was the well, Photo III-B-82. There is a solid ½" thick steel plate cover on the well. This cover is rusted and the paint finish is poor. A single floor drain is present near the center of the room as seen in Photo III-B-83. The cover is missing from this drain and it is plugged with debris. It is presumed that this drain emptied directly into the lake. In the southwest corner of the Equipment Room a concrete stairway provides access to the upper level. Refer to Photos III-B-84, III-B-85 and III-B-86. A steel pipe handrail is found along the first length of the stair. The poured concrete treads and risers are in good condition however, the paint finish is in poor condition. The small space below the stairway housed a bathroom with a water closet and sink. The plumbing fixtures are no longer present, however, some remnants of piping remain, as seen in Photo III-B-87. The wood door frame into this previous bathroom remains in place, however, the 2'-4" x 6'-7" door is missing.

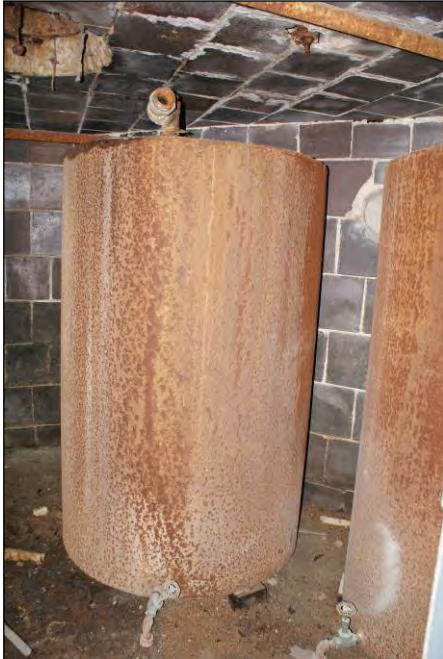
**Photo III-B-88**

At the far west end there is another room identified on the 1922 drawings as the Coal Room, however, the presence of four large tanks indicates that the use of this room was changed. Each of the four tanks is 4' in diameter and 6' in height. As with the other tanks, most of the piping is no longer present. These tanks are quite rusted as seen in Photo III-B-88. This photo also shows the unpainted glazed hollow wall and ceiling tile in this room. A 2'-6" x 6'-6" door leading into this room is missing. Previous Photo III-B-38 shows the interior side of the metal access hatch in the ceiling of the former Coal Room. Photo III-B-89 shows the presence of water leakage into the building at a location directly below the west wall of the wood frame structure above.

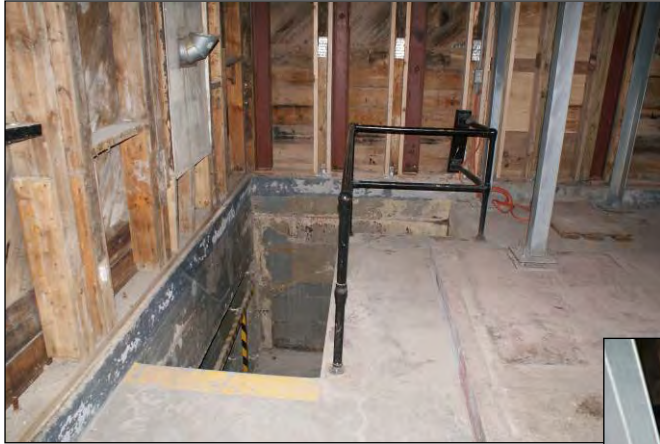
The interior concrete stairway allows access to the upper level of the Entrance Light, which is the original wood frame Fog Signal Building. Photo III-B-90 shows this stair as it transitions to the upper floor. A simple two pipe steel guardrail system, as seen in Photo III-B-91 protects the stair opening. There is no handrail on the upper run of the stair. This room is one large space with no interior finish material on the walls or ceilings; studs and ceiling joists are exposed as seen in Photos III-B-92. A small room measuring 8' x 13' constructed of 2" x 4" studs, wood paneling and gypsum board, is located within the large room, as seen in Photo III-B-93. Interior views of this room, Photos III-B-94 and III-B-95 show the damaged wall paneling and graffiti. A 2'-8" x 6'-8" hollow core wood door, Photo III-B-96, provides entry into this room. All elements of this room are in very poor condition.

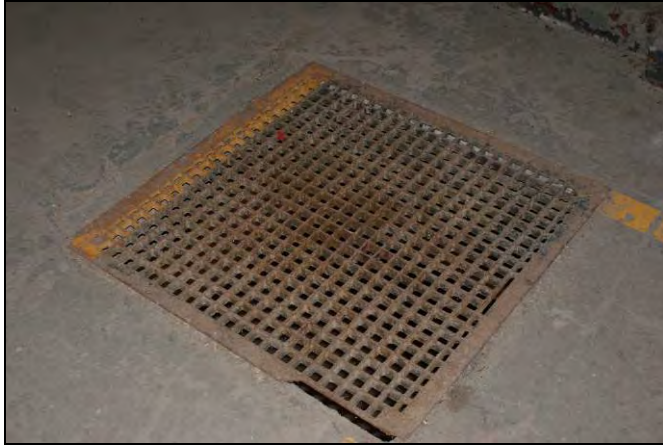
Photo III-B-97

There are four floor openings in the concrete floor slab that allow ventilation between upper and lower floors. One floor opening at the center of the room measures 2'-6" x 2'-6" and is covered with a steel grate, as seen in Photo III-B-97. Although this grate has a broken corner it is in good condition. A second floor opening that measures 2'-0" x 1'-9" is on the east side at the door opening. The grate over this opening, as seen in Photo III-B-98 is in good condition. A floor opening on the west side of the room below the lantern room is open and presents a safety hazard, as seen in Photo III-B-99. The metal grate is broken and stored against a wall. Refer to Photo III-B-100. The remaining floor opening, measuring 2'-0" x 1'-1", is along the north wall and is covered with a light gage metal grate that is bent and in bad condition, as seen in Photo III-B-101. The concrete floor / ceiling slab around this opening is badly spalled and there are remnants of a metal duct. Refer to Photo III-B-102. There are two six inch high raised concrete equipment pads in this room that present tripping hazards. See Photos III-B-103 and III-B-104. Exposed ceiling joists and the underside of partial sheathing material of the third level catwalk are visible throughout the room, as seen in Photo III-B-105.

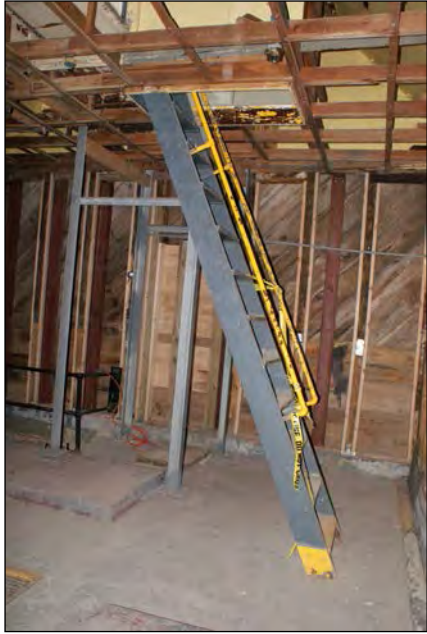
**Photo III-B-106**

A wood ship's ladder style stairway provides access from the upper level floor to the third level catwalk and lantern service room. This ladder, as seen in Photos III-B-106 and III-B-107, measures 2'-3" wide and has a steel pipe handrail on each side. The stair and the handrails are in good condition. Paint finish on the handrails is in poor condition.

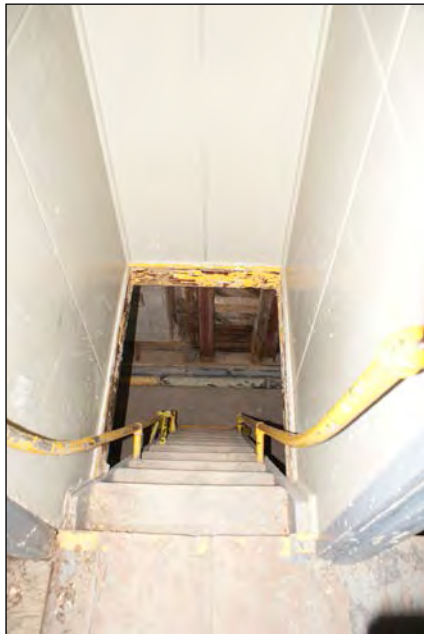
**Photo III-B-108**

The ship's ladder stair passes through a small floor opening, Photo III-B-108 that enters a small hallway at the third level, Photo III-B-109. A 2'-7" x 6'-7" door from the hallway to the catwalk is missing. A built-in storage compartment that measures 1'-4" wide by 2'-4" high is located on the south wall, as seen in Photo III-B-110. Hinges are intact but the compartment door is missing. Finishes in this small hallway include hardboard wall paneling, a tin ceiling and wood trim. All substrate materials are in fair condition. All surfaces are painted with paint surfaces in fair to poor condition.

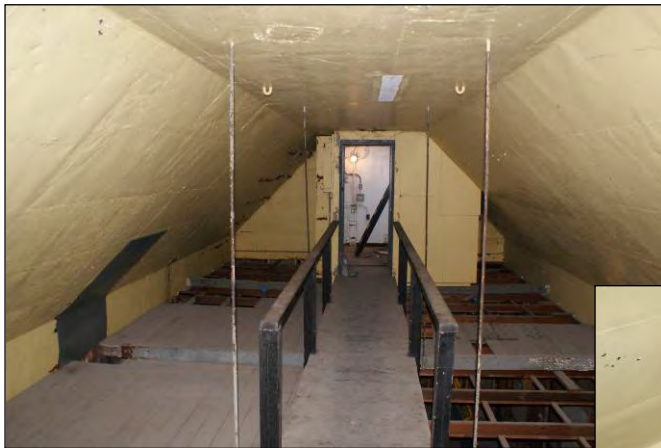
**Photo III-B-111**

To the east of the hallway is a 2' – 8 ½" wide wood catwalk that connects to the east end of the building where a former door was located. Views of this catwalk are seen in Photos III-B-111 and previous Photo III-B-13. The 3 ¾" x 1 ¾" painted wood handrails along the catwalk stop where plywood floor sheathing is laid on the ceiling joists, approximately 11'-8" from the east wall. The 5 1/2" wide wood sheathing is randomly place in different locations, however, much of the third level floor is open to below. Refer to Photos III-B-112 and III-B-113. Walls and ceilings of the third level are painted metal sheets as seen in previous photos. There are many rusted and deteriorated areas throughout, as seen in Photo III-B-114. At the far east end of the attic the former door opening, measuring 2'-7" x 5'-4", has been filled in with concrete masonry units. Two ventilation units are set into the masonry, as seen in Photo III-B-115. A small attic access hatch, measuring 1'-6" x 1'-3", is also located at the east end of the room. Refer to Photo III-B-116. There is also a floor and floor framing opening at the former chimney location. The wall and sloped ceiling area has been patched with metal sheets at this area, as seen in Photo III-B-117. This photo also shows the floor opening at the former chimney location. Two small lifting rings are set in the attic ceiling, as seen in Photo III-B-118.

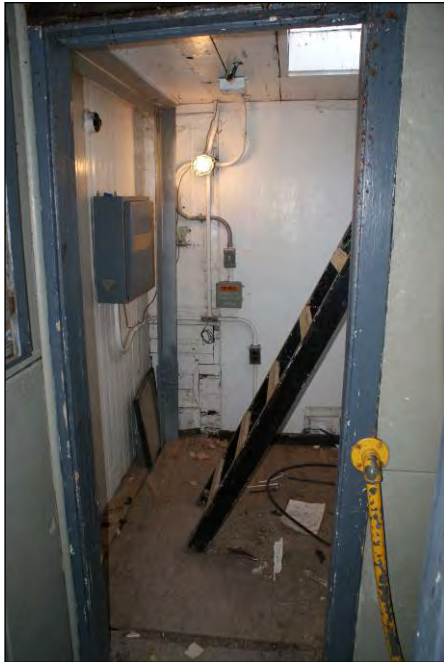
**Photo III-B-119**

To the west of the small hallway is the lantern service and fog horn room that measures 6'-0" x 5'-3". Based on historic photographs, the fog horn would have been located directly outside of this room and piping to the fog horn would have been inside the room. Photo III-B-119 shows a view looking into this room through the hallway door. This door frame measures 2'-6" x 6'-7" and the door is missing. A variety of electronic equipment is located in this room. Interior finishes include a plywood floor, 3 ½" wide vertical wood paneling and random width wood paneling on the ceiling. The wood substrate is in good condition, however paint finishes on the walls and ceiling are in poor condition. A small ladder leads to a 1'-2" x 2'-5" floor access hatch into the Lantern, as seen in Photo III-B-120. The ladder is in good condition but it is not properly secured. There is no floor hatch cover or lid and the floor opening presents a safety hazard for anyone in the lantern.

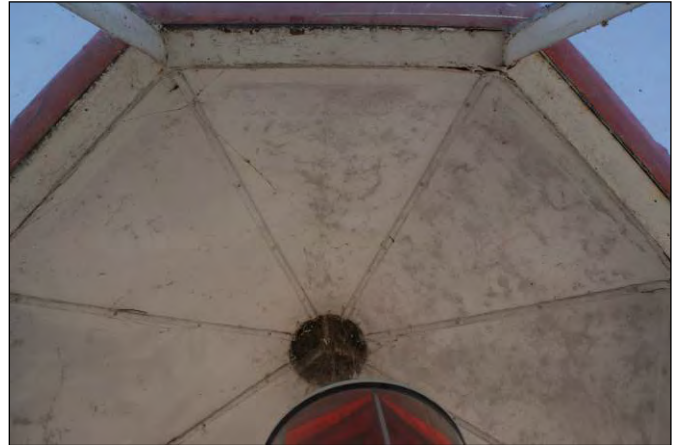
**Photo III-B-128**

Of the eight glazed openings in the Lantern three panels are glazed with Lexan material and two of the remaining five glass panels are broken. The glazed openings measure 2'-4 ½" wide x 3'-0 ½" high. The exposed metal sill and vertical mullions of the lantern are in good condition, however, the paint is in poor condition. There is considerable moss growth along the metal sill, as seen in Photo III-B-127. The lantern ceiling is exposed light gage metal with a paint finish. All metalwork is in sound condition, however, the paint finish on all surfaces is in poor condition. Refer to Photos III-B-128, III-B-129 and III-B-130.

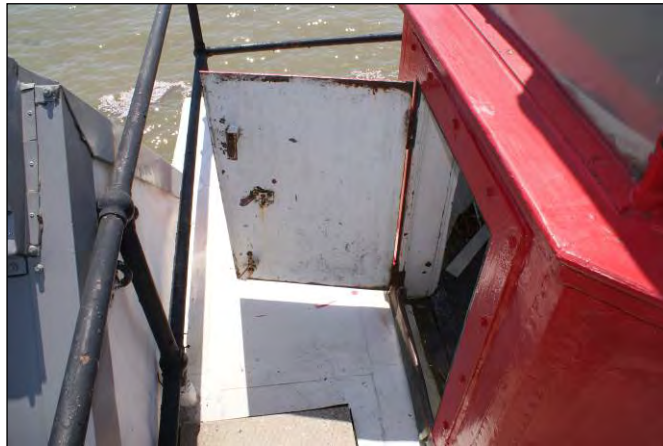
**Photo III-B-132**

The exterior of the lantern and the lantern deck is accessed through a 1'-8" wide x 2'-5" high access door on the east side of the lantern. Refer to Photo III-B-131. The door is a ¼" thick metal door as seen in Photo III-B-132. The door is in good condition, however, the metal flashing and roof membrane flashing at the door sill is in poor condition as seen in Photos III-B-133 and III-B-134. The wood floor and wood trim at the base is also in poor condition around the door opening.

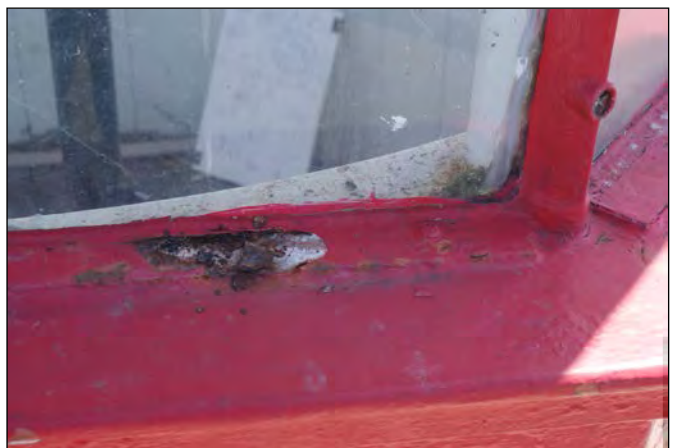
**Photo III-B-138**

The exterior of the lantern is shown in Photos III-B-135 and III-B-136. Exterior walls of the lantern are flush metal with a paint finish. Vents are simple capped openings, as seen in Photo III-B-137. Minor areas of damage including rust are found in various locations, as seen in Photos III-B-138, III-B-139 and III-B-140. The lantern roof is flat metal panels terminating at a simple fascia without gutters. All exterior metal on the lantern is in good condition. The paint finish is in average condition. At the peak of the lantern is a ventilator that was apparently installed as part of the 1922 renovation. It is identified as a “new ‘Kernchen’ ventilator” on these drawings and is shown in Photo III-B-141.

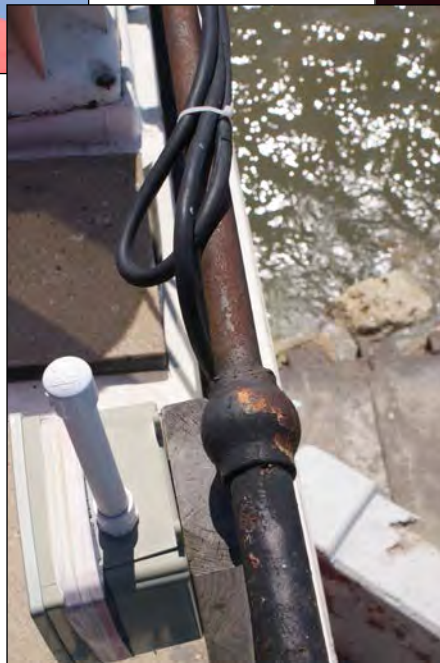
**Photo III-B-143**

The lantern deck is 11'-4" square with a metal pipe guardrail all around. The metal pipe guardrails and posts are 1 5/8" in diameter and have two horizontal members. The top rail is 2'-9" above the deck surface, as seen in Photo III-B-142. One original section of the top rail on the west side is missing and has been replaced with a metal pipe with a smaller outside diameter. Refer to Photo III-B-143. The metal railing is used to support navigation signage and brackets for various aids, as seen in Photos III-B-144 and III-B-145. The metal pipe rail system is in sound condition, however, the paint finish is in poor condition. The deck surface is covered with

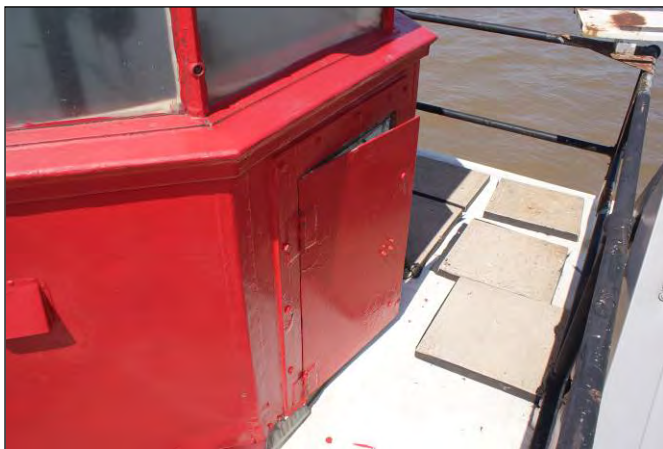
**Photo III-B-146**

a single ply membrane roof. Precast concrete walkway pads are placed on the roof for ballast as well as to provide a walking surface, as seen in Photos III-B-146 and III-B-147. This membrane is missing a very large section at the northwest corner of the deck, exposing the wood deck structure. Refer to Photos III-B-148 and III-B-149. This serious condition is allowing water to penetrate into the interior of the building. The roof membrane flashing wraps the guardrail posts, Photo III-B-150 and the gable end of the main building roof, Photo III-B-151. Other navigation aids, such as the fog signal device shown in Photo III-B-152, are also located on the lantern deck surface.

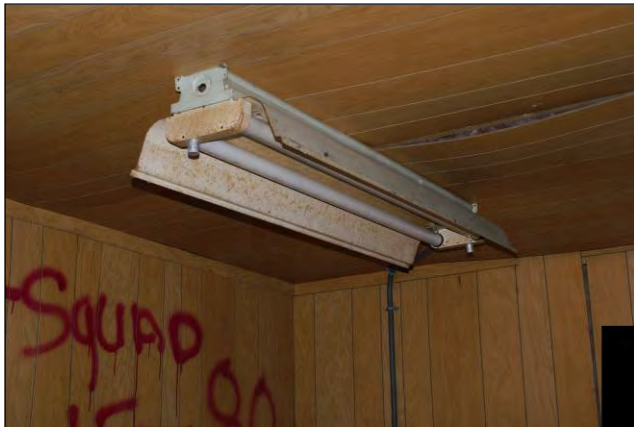
**Photo III-B-158**

A small number of lights and switches, most of which are operational, are located throughout the building. A non-operational fluorescent fixture, Photo III-B-158, is located in the upper level equipment room. Wall mounted fixtures, Photo III-B-159, are located on the upper floor level and similar fixtures are ceiling mounted in the various rooms on the main floor level, Photo III-B-160. Light fixtures on the upper and lower levels are controlled by a timer switch located near the entry door. A single light fixture, Photo III-B-161, and duplex receptacle, Photo III-B-162, are located in the lantern service room. All conduit is exposed.

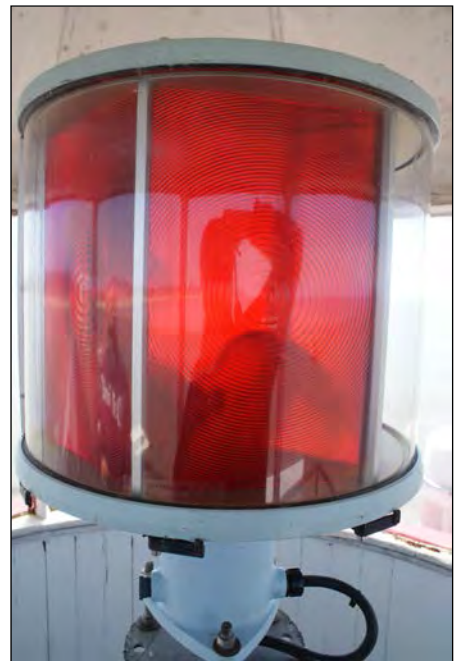
**Photo III-B-163**

The navigation light located in the lantern is a red Marine Rotating Beacon, Model VRB-25, Serial No. 25-036, manufactured by Vega Industries, Ltd. This light, which is functional and maintained by the U.S. Coast Guard, is seen in Photo III-B-163.

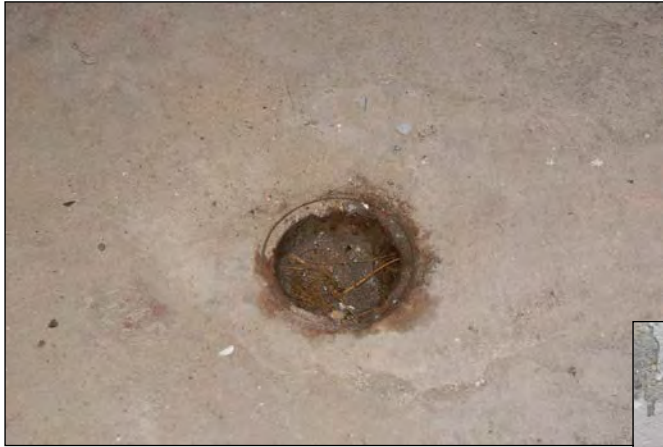
**Photo III-B-164**

Plumbing fixtures including a water closet and lavatory were installed in the building as part of the 1922 renovation. These fixtures are no longer extant. Some plumbing piping remnants remain such as the floor drain located in the main level, Photo III-B-164, and a plumbing clean-out located on the south wall, Photo III-B-165. Drawings indicated that the waste lines drained to the lake. There is no evidence of water supply piping from the well located in the main level, shown in previous Photo III-B-82.

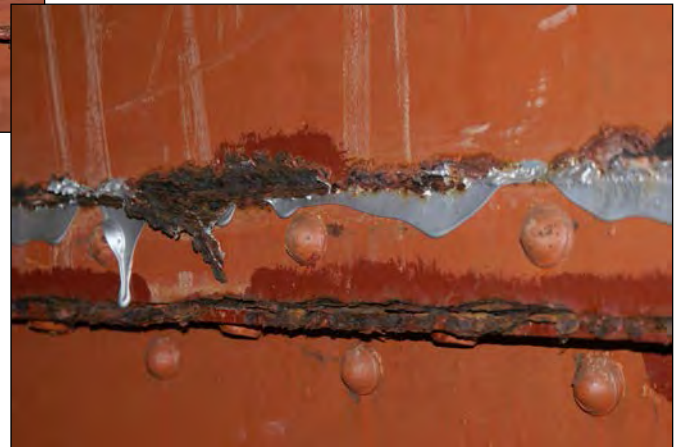
**Photo III-C-4**

Interior views of these horizontal joints are shown in Photos III-C-3 and III-C-4 which show rust sealant material, and coatings of rust inhibitive primer. Internally there are a number of struts, bracing and other metal framework that reinforce the structure and provide framing for the floors. Photos III-C-5 and III-C-6 show some of the internal framework, which is in relatively good condition.

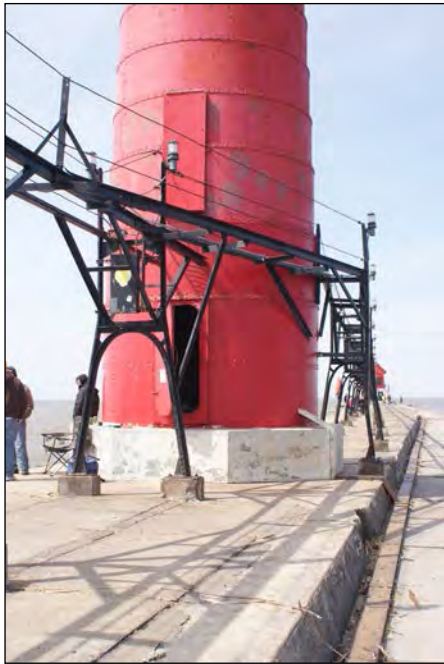
**Photo III-C-7**

The metal tower is placed on an eight sided solid concrete base that extends 2'-8" above the pier deck surface, as seen in Photo III-C-7. The overall depth of the concrete base is not known but it is presumed to tie into the superstructure of the pier. The concrete base provides the floor structure at the main level of the tower. Refer to Photo III-C-8. As with the horizontal joints in the steel structure, the outer ledge of the concrete base allows water to flow into the interior.

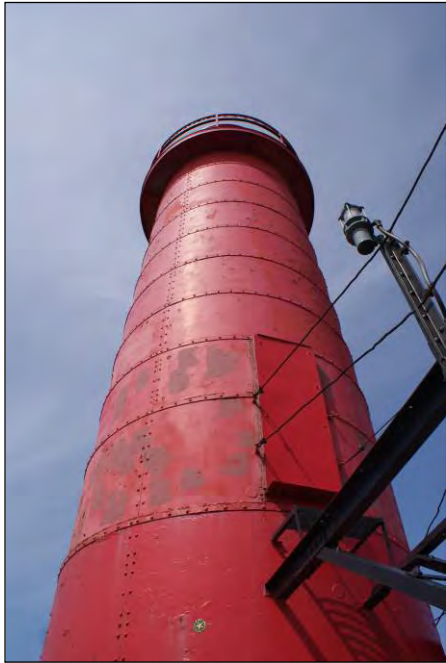
**Photo III-C-9**

The exterior of the Inner Light is a simple metal structure with exposed metal plate, angles and rivets. All metal surfaces are painted and the paint finish is in poor condition. Refer to Photo III-C-9. Many metal surfaces have extensive rust and scale. The elevated catwalk structure is framed into the east side of the tower and then makes a dog-leg around the tower as it continues to the west. Views of the catwalk framing from the top of the tower are shown in Photos III-C-10 and III-C-11. Angles and brackets are welded to the exterior face of the tower, as seen in Photos III-C-12 and III-C-13. Extensive rusting has occurred around some brackets and the paint finish is in poor condition as seen in Photo III-C-14. The concrete base, which is in good condition, has a paint surface that is in poor condition.

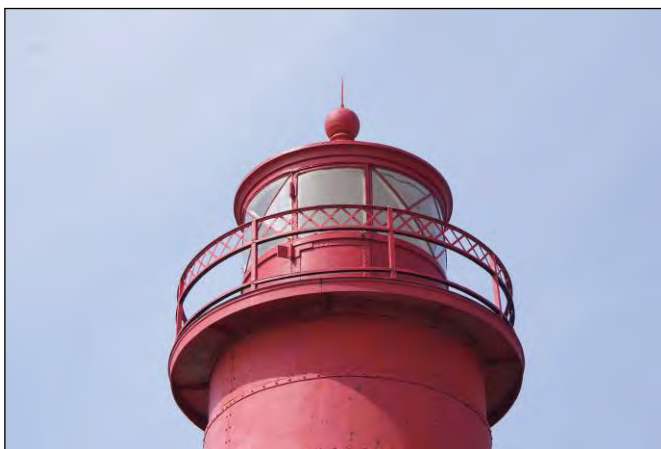
**Photo III-C-15**

The lantern and lantern deck are placed on top of the cylindrical structure approximately 41'-8" above the main pier deck surface. The cylindrical lantern, Photo III-C-15 is 7'-8" in diameter and the circular lantern deck is approximately 13'-0" in diameter. The lantern deck is surrounded by a 3'-0 1/2" high decorative metal guardrail with a lattice pattern constructed of 1" x 1/8" flat bar as seen in Photos III-C-15 and III-C-16. The top rail is a 2" x 1 1/2" flat metal bar, and the bottom and intermediate rails are 2" wide "U" shape sections. All are connected to 2" x 2" square steel posts as seen in Photo III-C-17. The bottom horizontal rail is rusty and some connections at the posts are weak. All other guardrail components are in good condition except for some rusted areas. Paint finish is in poor condition on all guardrail components. The exterior lantern deck is metal plate that is in good condition. Paint finish is in poor condition.

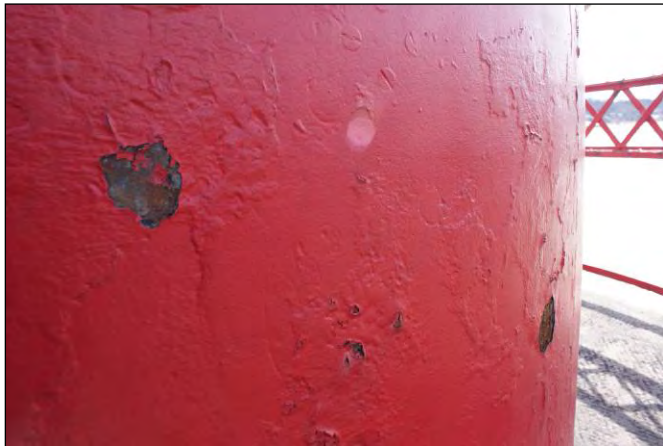
**Photo III-C-18**

The lower walls of the lantern are curved metal with a paint finish. The exterior face of the walls are in good condition, however, the paint finish is in poor condition, as seen in Photo III-C-18. Four vent openings with perforated metal covers, Photo III-C-19, are placed around the perimeter of the lantern. One vent opening has been covered with a solid metal plate, Photo III-C-20 and at another location the cover is missing, Photo III-C-21. The lantern glazing is a unique diamond pattern, Photo III-C-22, with curved glazing mullions. Exterior glazing bars, 7/8" and 1 1/16" wide are curved and screwed into the supporting mullions, as seen in Photo III-C-23. Of the twenty openings, seven are glazed with Lexan. The remainder of the openings are glazed with curved glass which is in good condition.

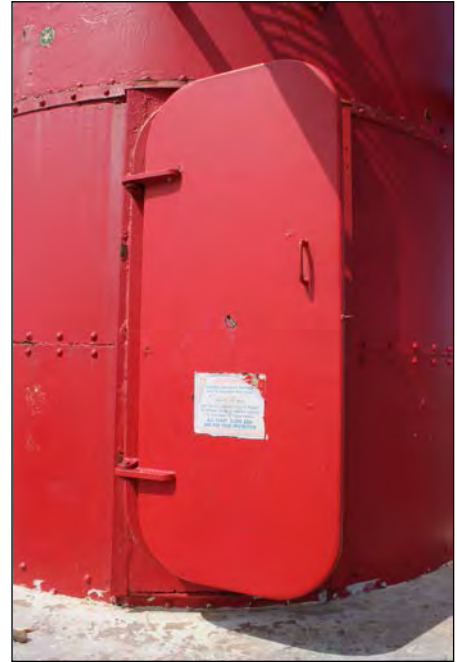
Photo III-C-28

The Inner Light tower is entered through a 2'-2" x 5'-6" gasketed, water-tight steel door, as seen in Photos III-C-27, III-C-28 and III-C-29. This style of door also has a continuation of the frame at the bottom of the opening, requiring extra caution when stepping through. This condition is seen in Photo III-C- 30. The door hardware consists of a pull handle and padlock hasp on the exterior and a multi-point lock mechanism on the interior. All door components are in good condition and operating order. Paint finish is in poor condition. The original 1922 drawings indicate a solid steel plate door. The water-tight door was installed in the 1990s.

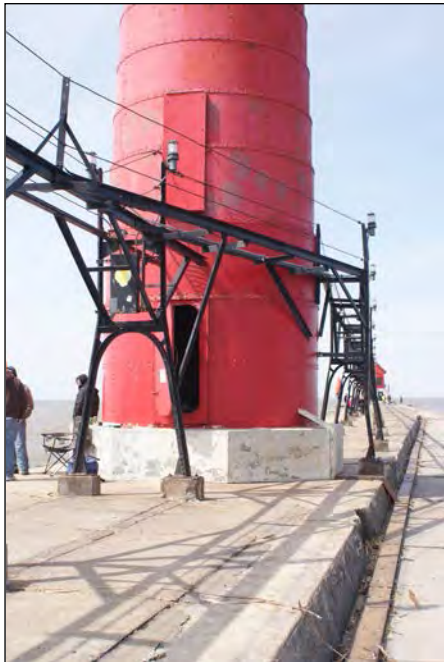
**Photo III-C-31**

A former door opening was located at the second level where the catwalk met the light tower, as seen in Photo III-C-31 and III-C-32. This door opening, 2'-0" x 6'-5" is now covered with a metal plate that is bolted and caulked in place. An interior view of this door opening is seen in Photo III-C-33.

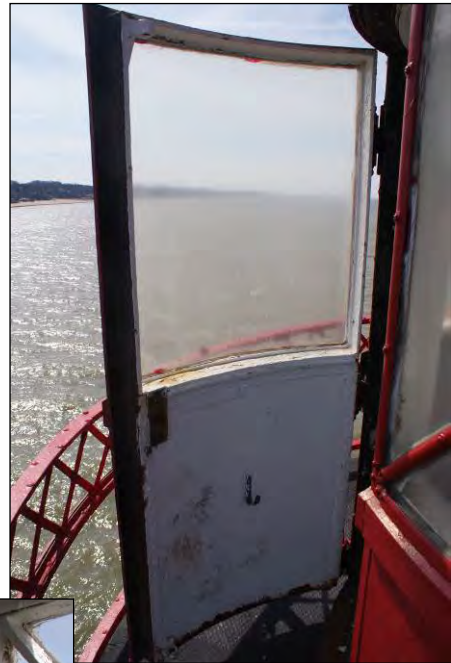
**Photo III-C-35**

The lantern door is a large metal and glass door 2'-3 ½" wide by 5'-10" high that is curved to match the curvature of the lantern. Refer to Photos III-C-34, III-C-35 and III-C-36. The original curved glass has been replaced with Lexan. There is a major crack in the metal door at the lower northern corner of the glazed opening directly above the latch. The crack is completely through the metal and affects the integrity of the door. Another area of concern is a loose middle hinge, as seen in Photos III-C-37. This hinge is no longer connected to the body of the lantern, with the door only supported on the lower and upper hinge, Photo III-C-38. The head and sill of the door are shown in Photos III-C-39 and III-C-40. Door frame metalwork is in good condition, however, all paint finishes are in poor condition. Door hardware consists of a small turn handle on the exterior, Photo III-C-41, and partial components of a vertical rod latch mechanism, Photo III-C-42. Remnants of the vertical rod latch device are laying in the lantern, as seen in Photo III-C-43.

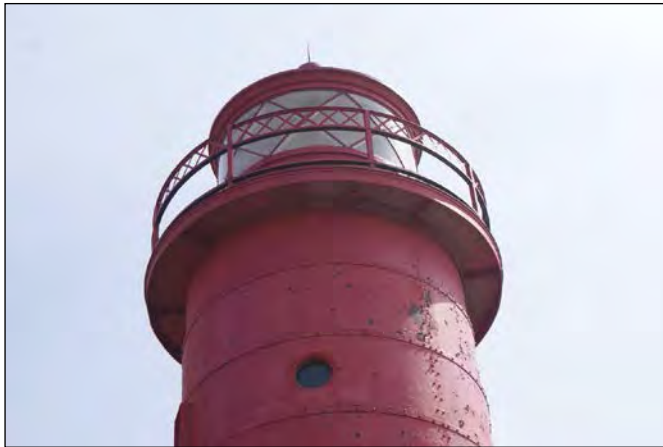
**Photo III-C-44**

Other than the lantern glazing, previously discussed, window openings include five small porthole style windows located at different elevations along the height of the tower. These porthole windows are seen in previous photographs and Photo III-C-44. The inward swinging sash at the two porthole windows at the first level are missing and a steel plate cover has been welded to the frame, as seen in Photo III-C-45. The operable sash and glazing are intact at the three window openings at the upper levels. Refer to Photo III-C-46. The inward swinging sash is 1'-4" in diameter with a 1'-2 1/2" diameter glass opening. Paint finish is in poor condition on all windows.

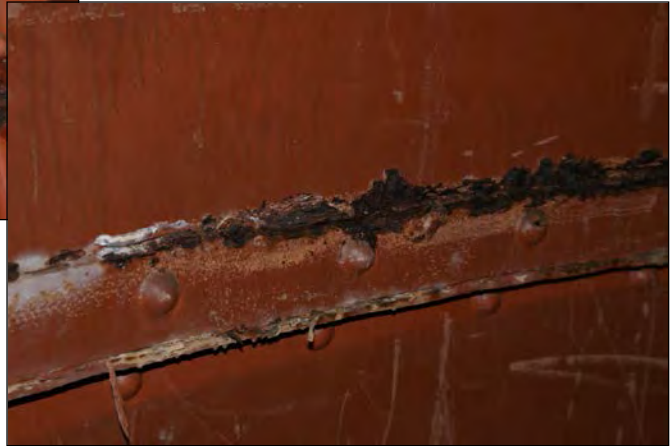
**Photo III-C-51**

The interior of the Inner Light tower is a simple and utilitarian space consisting of open rooms and stairs that allow access to the lantern and the light. All walls are the inside face of the metal cylindrical sections that form the structure of the tower. The main floor, at 2'-8" above the pier deck surface, is an open room approximately 12'-4" in diameter with a series of electrical panels and the circular stair that provides access to the second level. A partial view of this room at the bottom of the stair is seen in Photo III-C-47 and a view looking up in Photo III-C-48. The concrete floor slab is in reasonably good condition with some minor spalling and deterioration at the entry door. There is moisture around the perimeter where the metal cylindrical walls sit upon the concrete base. Refer to Photo III-C-49. There is considerable rusting along many of the horizontal joints around the perimeter walls, as seen in Photos III-C-50 and III-C-51. All interior wall surfaces are painted with a red primer paint that is in poor condition.

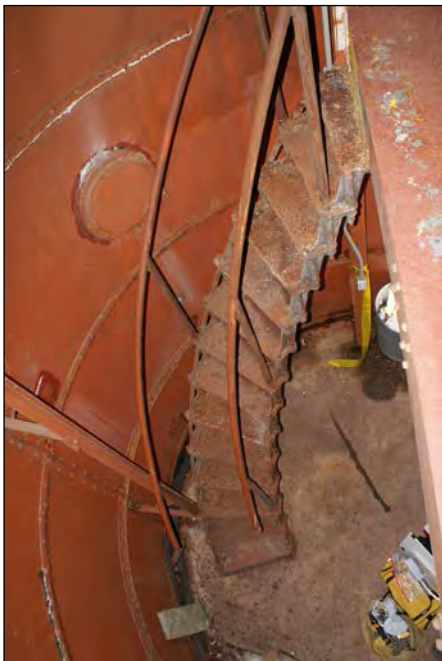
**Photo III-C-52**

The curved 2'-0" wide metal stair, as seen from the second level in Photo III-C-52, provides access to a partial floor that is 11'-1" above the main level. A metal pipe handrail is present on both sides of the stair. The second floor level, which functions as more of a stair landing, is only one-half of the floor structure and 11'-9" in diameter as seen in Photo III-C-53. The open side of the floor, which is constructed of  $\frac{1}{4}$ " thick steel plate, is protected by a single  $1\frac{5}{8}$ " steel pipe guardrail that is 3'-2" above the floor. With no intermediate rail or toe plate, as seen in Photos III-C-54 and III-C-55, this is a rather dangerous condition for people on this level. At the base of the stair that goes up from this second level there is an unprotected floor opening along the outside wall that also presents a safety concern. This condition is shown in Photo III-C-56.
