**HISTORIC STRUCTURES REPORT**  
for  
**GRAND HAVEN SOUTH PIER**  
**ENTRANCE AND INNER LIGHTS**  
Grand Haven (Ottawa County), Michigan

**Grand Haven Lighthouse Conservancy**  
and  
**City of Grand Haven**  
519 Washington Avenue  
Grand Haven, Michigan 49417

**Sanders & Czapski Associates, PLLC**  
109 S. Front Street, Suite #210  
Marquette, Michigan 49855

**FINAL REPORT**  
**September 8, 2015**

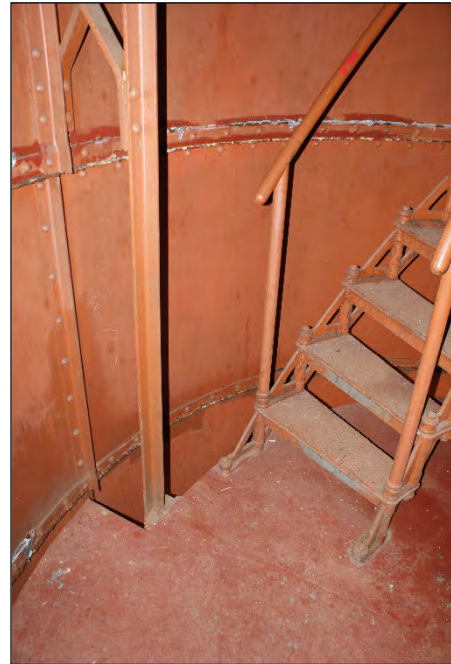
**Photo III-C-56**

The curved 2'-0" wide metal stair, as seen from the second level in Photo III-C-52, provides access to a partial floor that is 11'-1" above the main level. A metal pipe handrail is present on both sides of the stair. The second floor level, which functions as more of a stair landing, is only one-half of the floor structure and 11'-9" in diameter as seen in Photo III-C-53. The open side of the floor, which is constructed of  $\frac{1}{4}$ " thick steel plate, is protected by a single  $1\frac{5}{8}$ " steel pipe guardrail that is 3'-2" above the floor. With no intermediate rail or toe plate, as seen in Photos III-C-54 and III-C-55, this is a rather dangerous condition for people on this level. At the base of the stair that goes up from this second level there is an unprotected floor opening along the outside wall that also presents a safety concern. This condition is shown in Photo III-C-56.

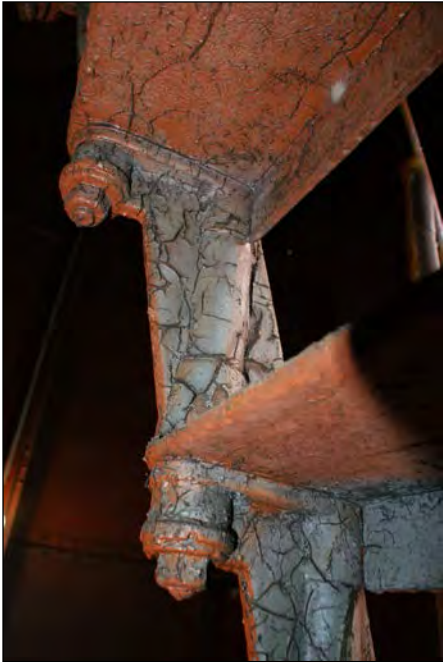
Photo III-C-59

From the second level, the curved metal stair goes up 15'-10  $\frac{3}{4}$ " to the third level, Photo III-C-57. Photo III-C-58 shows the intricate tread and riser system typical of the circular stair in this tower. The paint finish, as seen in Photo III-C-59, is in poor condition on all stair components. A floor opening allows access from the stair to the third floor, as seen in Photos III-C-60 and III-C-61. Two hinges remain on the outside edge of this opening indicating the past presence of a hatch cover at this opening. Photo III-C-62 shows one of the hinges. A simple two pipe guardrail, constructed of 1 5/8" diameter steel pipe protects this opening, as seen in Photo III-C-63. The third floor level, which is 10'-8" in diameter, is constructed of  $\frac{1}{4}$ " thick steel plate. There is severe water penetration through the tower walls that is collecting at this floor level, as seen in Photos III-C-64 and III-C-65. The steel plate floor is severely rusted and appears weakened in one area. A loose steel cover plate, Photo III-C-66, is positioned over a 12" diameter floor opening. Because this cover plate is not secured, this floor opening is a safety hazard.

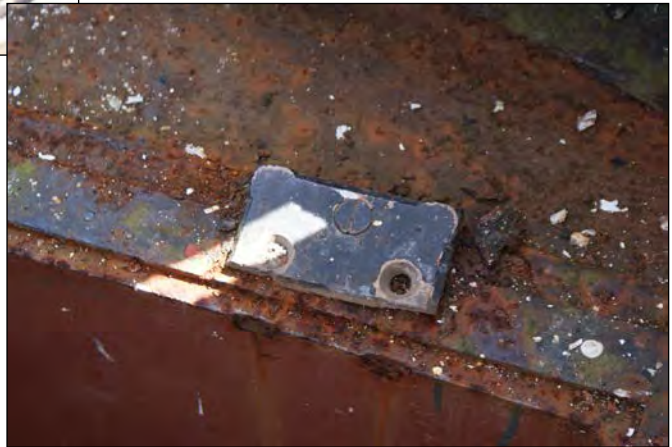
**Photo III-C-70**

A fixed steel ladder with double rungs provides access to the lantern. Refer to Photo III-C-67. A 1'-11" x 2'-5" floor opening in the lantern floor is seen in Photos III-C-68 and III-C-69. Two damaged hinges, Photo III-C-70, are found along the edge of the opening and the steel plate hatch cover is removed and laid against the lantern wall as seen in Photo III-C-71. The ceiling of the third level, or the underside of the lantern deck floor, is cement plaster which is in poor condition. Photo III-C-72 shows the loose and missing plaster. The paint finish is in poor condition.

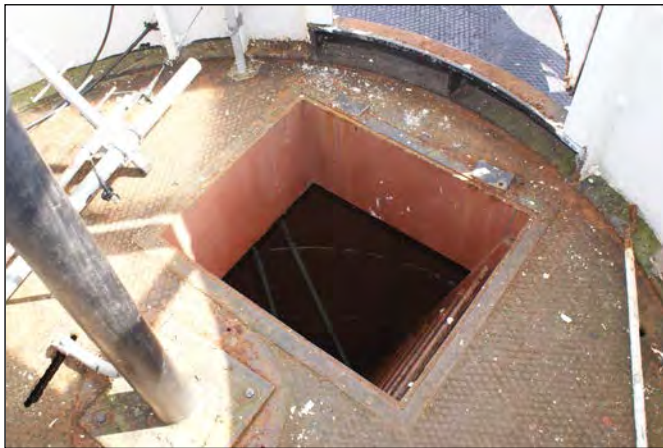
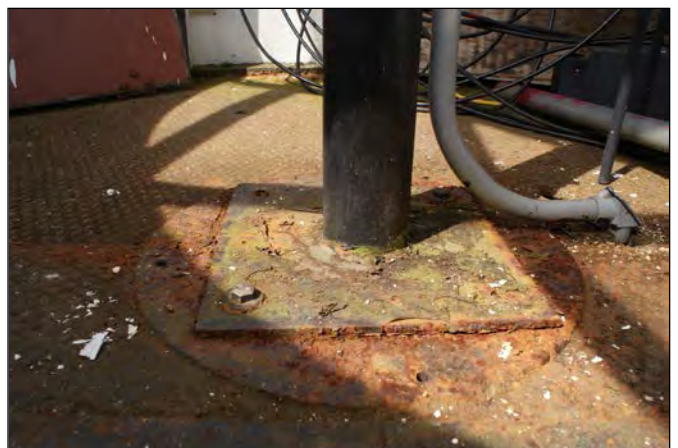
The lantern is cylindrical with an inside diameter of 7'-7" and houses the navigational beacon. The lantern floor is metal plate. The paint finish on the floor is in poor condition as seen in Photos III-C-73 and III-C-74 with water penetration and rusting occurring at the edge of the lantern walls, Photo III-C-75. Eight sections of wall panels form the base of the lantern that is 3"-6 5/8" high, as seen in Photo III-C-76. Four vents are symmetrically placed around the lantern. All are missing the covers, as seen in Photo III-C-77. The wall panels transition to a unique diamond pattern curved glazing system, Photos III-C-78. The diagonal mullions are in good condition, however, the paint finish is in poor condition. As previously discussed there are twenty two glass panels. Fifteen are curved glass and seven panels have been replaced with Lexan material. The original glass panels are in good condition. The lantern glass transitions to a metal ceiling, as seen in Photo III-C-79. The metal ceiling panels, which are topped by a vent as seen in Photo III-C-80, are in good condition. All paint surfaces are in poor condition.

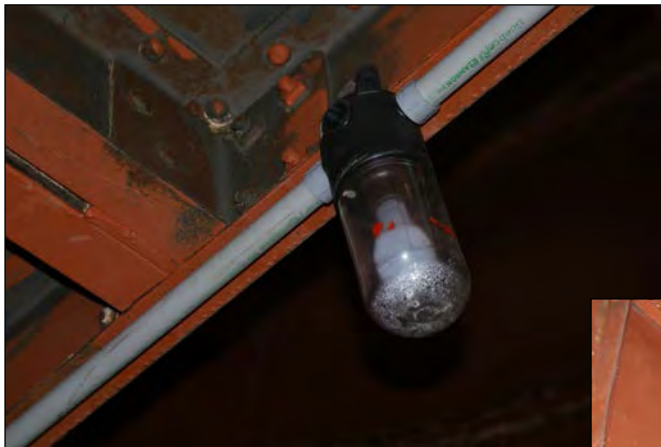
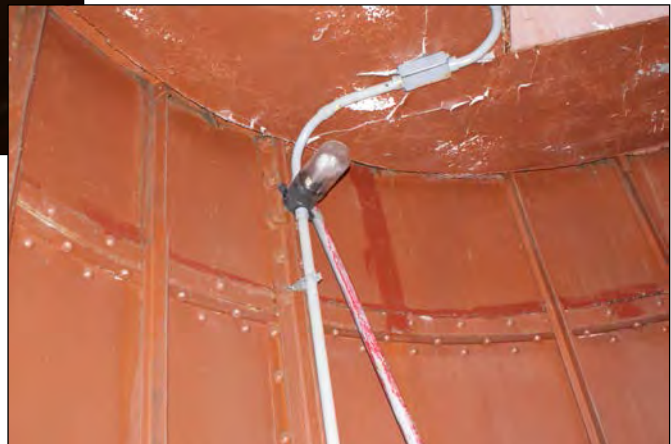
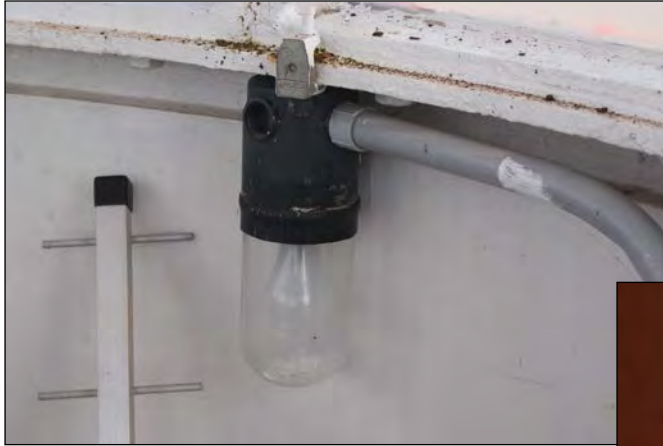
A small number of light fixtures are placed throughout the interior of the light tower and lantern, as seen in Photos III-C- 89, III-C-90 and III-C-91. A timer switch, Photo III-C-92, is located on the main level at the entry door and controls all lights. A few duplex electrical receptacles are located throughout. Wiring to all lights and receptacles is placed in PVC conduit.

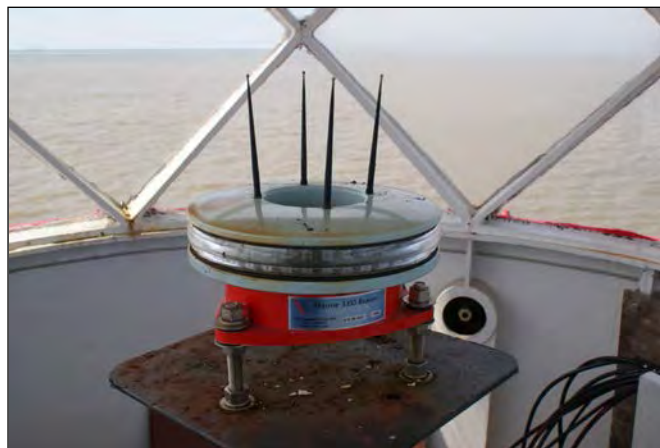
**Photo III-C-93**

The navigation light located in the lantern is a Marine LED Beacon manufactured by Vega Industries, Ltd., Model Number VLB – 38, Serial Number 38-0261-1999. This light, which is maintained by the U. S. Coast Guard, is shown in Photo III-C-93.
